VIBRATION PROPERTIES OF TRADITIONAL MASONRY WALLS OF CORTES CHURCH

The Santo Niño Church in Bohol Island was partially damaged in the Bohol Earthquake in October 2013. In this study, we investigated the structural property of the Santo Niño Church to understand the vibration characteristics of Philippine masonry constructions by checking the main damage and conducting measurement surveys and microtremor measurement on the structure and ground. The major findings of this study can be summarized as follows: (a) Collapsed walls, peeling wall stone, corner deformation, and collapsed ceiling were the main damages that were observed. The collapsed wall was measured, and the make-up and material thickness of the wall was verified. (b) By performing microtremor measurements on the walls, the vibration property of the church, such as the natural frequency and vibration mode of the longest wall A was clarified. The 1st natural frequency of the longest wall A is the lowest.

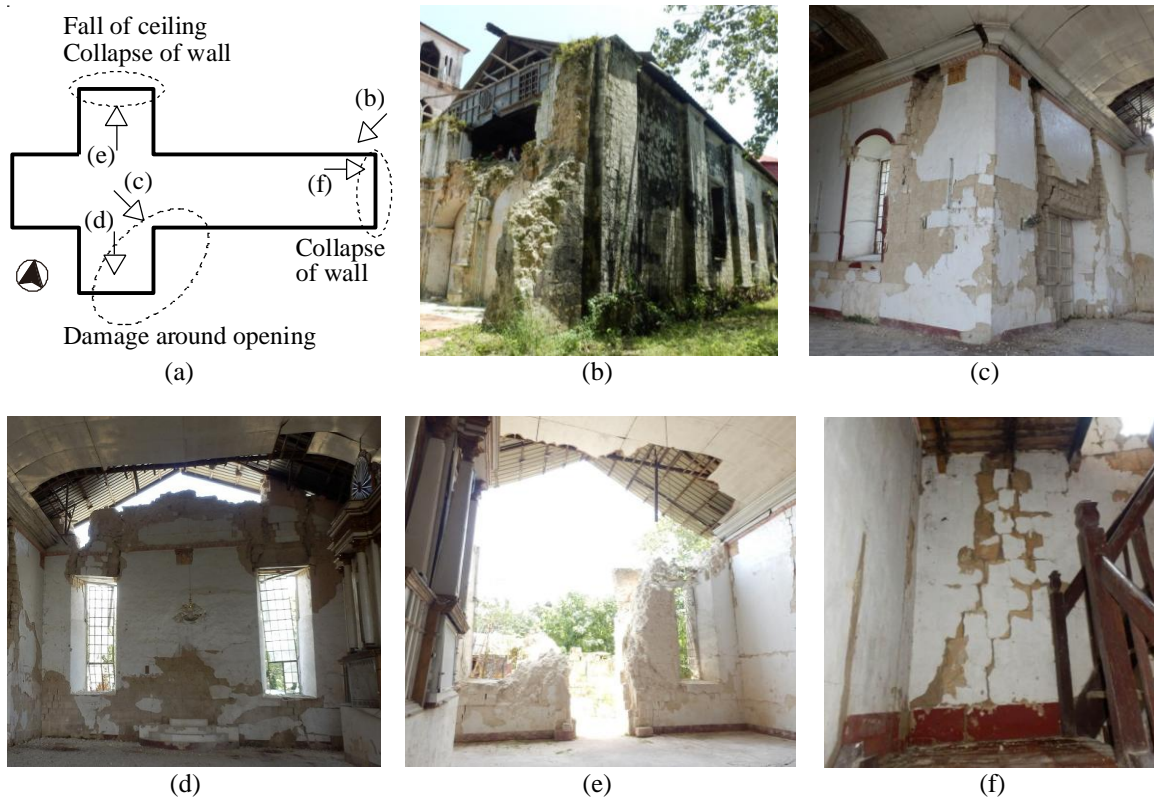
Figure 3. Damage due to Bohol earthquake; photographed on August 1, 2014.

Collapsed walls, peeling wall stone, corner deformation, and collapsed ceiling were the main damages observed. The points of main damage are illustrated by dashes line and arrow head in Figure 3 (a). Then, (b) to (f) say the photographing point of Figure 3 (b) to (f).

The eastern wall of the second floor collapsed, as shown in Figure 3 (b); significant damage was observed around the opening and top of the southern gable wall, as shown in Figure 3 (c) and (d). The northern gable wall collapsed completely, as shown in Figure 3 (e). The shear deformation of the eastern wall of the ground floor is shown in Figure 3 (f). Such types of damage were observed throughout the church.

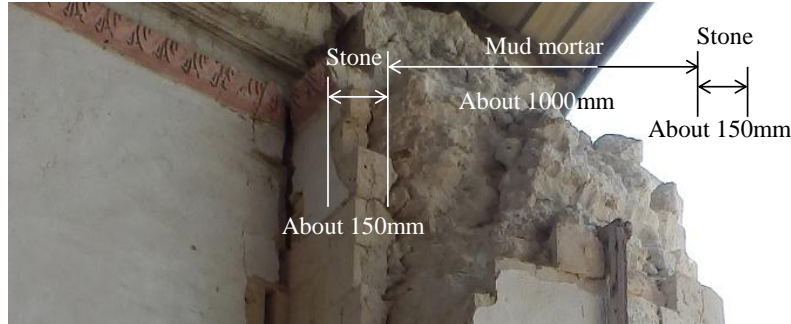
Figure 4. Construction of wall.

As the entire northern wall collapsed, the make-up and material thickness of the wall could be verified, as shown in Figure 4. Coral stones are arranged on both surfaces of the thick wall; the radius and thickness of each stone was approximately 300 mm and 150 mm, respectively. The space between the coral stones is filled up with mud mortar, which had a thickness of approximately 1000 mm.

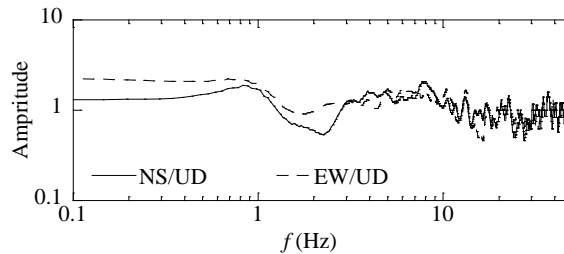
Figure 5. H/V spectrum on the ground point.

We conducted microtremor measurements of the ground to clarify surface conditions. The measurement was performed on the free ground at x point, as shown in Figure 2 (c). The frequency of the ground ranged between 7–9 Hz, as shown in Figure 5.

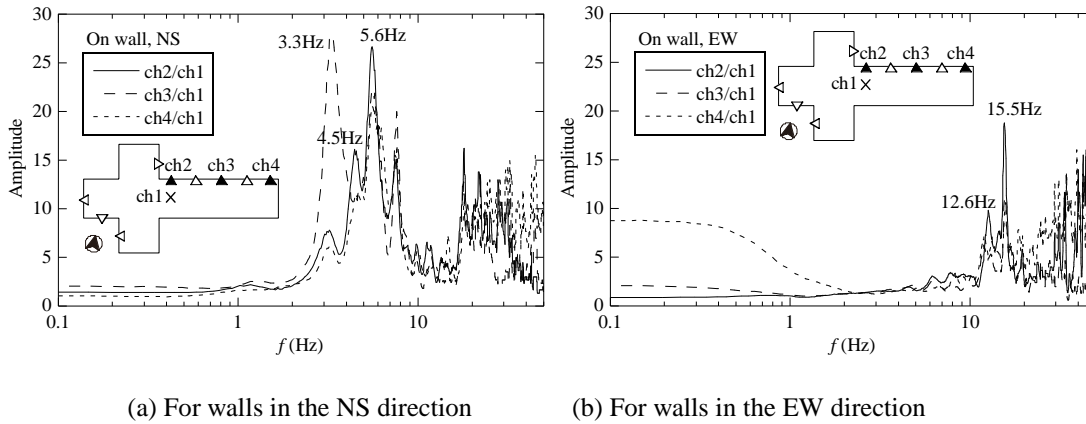
Figure 7. Fourier spectral ratio.

Fourier spectral ratios in the out-of-plane and in-plane directions, obtained using the three sensors installed in wall A, are illustrated in Figure 7. The peaks are clear in both directions; the 1st, 2nd, and 3rd natural frequencies in the out-of-plane direction are 3.3 Hz, 4.5 Hz, and 5.6 Hz, respectively. In addition, the 1st and 2nd natural frequencies in the in-plane direction are 12.6 Hz and 15.5 Hz, respectively. The 1st natural frequencies of walls A to E in both the directions are indicated in Table 1.

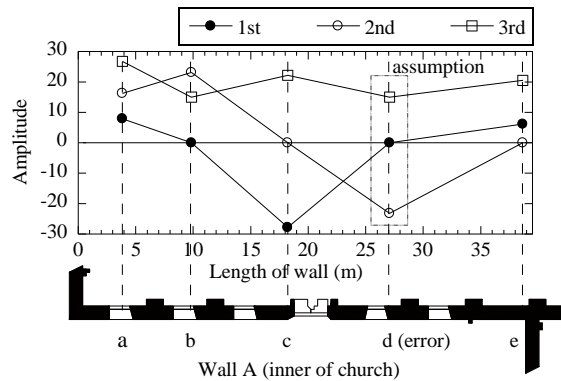
Figure 8. Vibration mode of Wall A.

The vibration mode of wall A is shown in Figure 8. The five sensors are named a to e, and the 1st to 3rd modes are illustrated. As measurement could not be performed using sensor d, the value of sensor b is used, based on a past study (Takiyama 2012).
