## REHABILITATION AND LOAD TESTING OF A BRIDGE

KAWAN G. ALANI<sup>1</sup> and ABDULLAH S. AHMED<sup>2</sup>

<sup>1</sup>*Alani & AlShamma Consultancy Bureau , Baghdad, Iraq*

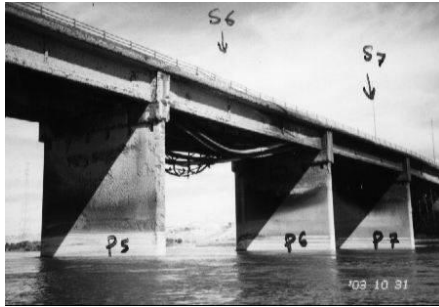
- A complete collapse of span nine.
- Large opening in the middle of the upstream carriageway of span six with heavy damage of its middle girder.
- Excessive deflection of the downstream carriageway of span eight.

- The other spans were affected to a varying degree, where the fire had caused peeling of concrete cover and the exposure of reinforcing bars. Cracking appeared in some of the main girders.

- The two abutments show only minor damages.
- Piers P1, P2 and P3 were in good conditions except for their crossheads which suffered moderate to minor damages. Piers P6, P7, P8 and P9 suffered heavy damages throughout their exposed parts above water line. While piers P4, P5 suffered moderate damages at parts above the mid height of piers.

Figure 1. Damages of bridge.

- Most of the expansion joints were damaged.
- After thorough study of the results of inspections, it was decided to replace spans six to ten and demolishing the exposed parts of piers P6, P7, P8, and P9, then rebuild them to the original design.

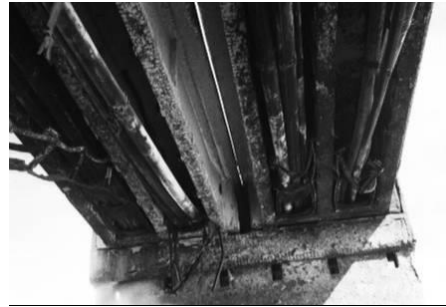
- As for the rest of the bridge parts, which mainly suffered from exposure to fire, a decision was taken to restore them to their original capacity by carrying out engineering repair work. Among these, span five being closed to span six, which was subjected to the direct attack, and hence suffered more from the fire caused by the attack. See Figure 2. Thorough inspection of span five was conducted and the state of each girder was documented. In general, the elements of the deck structure did not exhibit signs of distress, like excessive deflection and/or heavy cracking.

Figure 2. Damages of span five.

As a conservative assumption, only the four straight prestressing cables are assumed to be effective in resisting the applied moments in the girders. Calculations of the resisting moment were carried out according BS5400-P4. The calculation of maximum bending moments and shear forces due to factored loads are less than the calculated resisting capacity of the girder. From these calculations, it was concluded that additional external reinforcement will not be necessary, Alani & AlShamma Consultancy Bureau Report (2010).

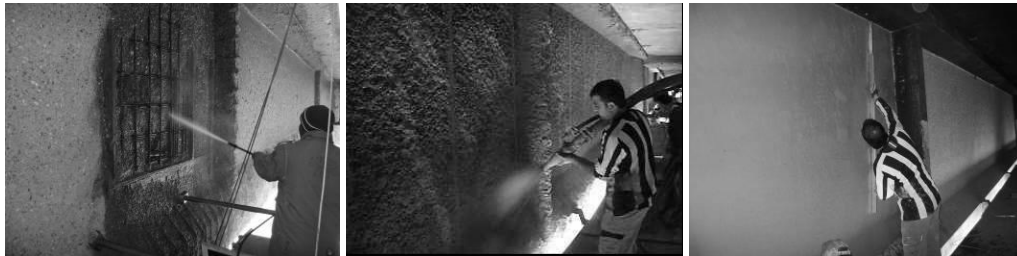
Figures 3, 4, & 5. Different stages of repair work.

- The removal of all the loose materials until a layer of sound concrete was reached.
- Then a water jet was applied to the exposed areas of concrete in order to remove the dust and the remaining loose materials, thereby leaving clean and sound surface. See Figure 3.

- The next step was to fill all visible cracks with structural quality injection material, i.e., low viscosity high strength epoxy sealing system conforming to ASTM C881 Specification. Injection material was selected and applied according to the instructions of the manufacturer. This type of material can be used to seal cracks up to 50mm width.

- After completion cracks injection work, the following task was to apply the replacement for the damaged surface layers. For this task, high quality shrinkage compensated cementitious material with polymer fiber reinforcement in order to reduce cracking, and with good bonding properties with underline concrete was chosen. A suitable material was chosen and applied by pressure sprayer. See Figure 4. Because the areas which were covered were large, they were divided to small panels by narrow guiding strips made of the same material to the required thickness. Then these panels were sprayed and troweled to the accurate level of the guiding strips. See Figure 5.

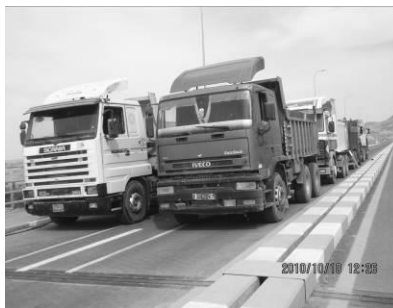
A carriageway 7.1m wide, according to BS5400-P2, consists of two notional lanes. For design purposes, either the two notional lanes are loaded with full HA load, or one lane is loaded with full HA load while the other is loaded with HB load. For an effective span for girders of 41.44m, the total span load which gives maximum deflection at mid-span was determined to be about 2000kN. To simulate the effect of this load, eight trucks were selected each weighs 250kN. See Figure 6. This load was applied in four increments; each consists of two trucks, i.e., 500kN per increment.

Figure 6. Load test (full load stage).

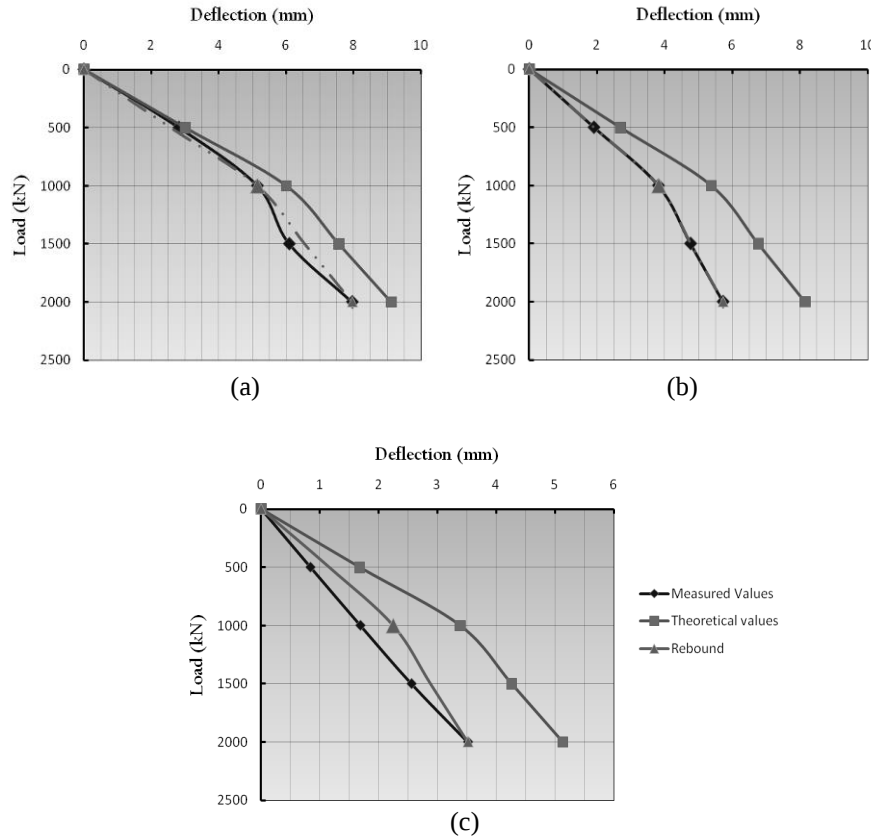
Figure 7. Load-deflection at midspan (a) girder 1. (b) girder 2. (c) girder 3.

Graphs of measured and calculated deflections at mid-span of the three girders are plotted against loading. See Figure 7. In this Figure, the theoretically calculated deflections are higher than the measured values. The graphs of measured deflections show complete recovery of deflection after removal of loading.

- The complete recovery of deflection after removal of the applied load means that the deck structure was acting in the elastic range of the material (elastic behavior).
- The measured maximum deflections of girders are smaller than the calculated values for the same loading conditions may be attributed to that the approximation used in the modeling of the structure is on the conservative side and that the repair material properties are appreciably higher than the concrete used in the original structure, i.e., the repair material has little bit higher modulus of elasticity ( $E_c$ ).
