REHABILITATION OF BRICK-WALL FAÇADES

VITOR ABRANTES¹, NUNO ABRANTES², and FERNANDO BRANDÃO ALVES³

This abstract seeks to analyze several existing cracking rehabilitation techniques on brick-wall façades. The examples concern to an upper-middle class housing complex, situated in Porto, Portugal. This housing complex holds 4 buildings (190 dwellings) and which construction is near 20 years old. The most significant anomalies that have been checked on this rehabilitation study were the cracks of the lintels over windows and on wall-corners of balconies. Both represent a severe anomaly on brick-wall façades that will have as consequence rain penetration and water infiltration. As result, one found that the horizontal lintel cracks occur as a consequence of conception mistakes due to a reduced armor support and to a poor covering. The lintel deformation will allow rain penetration through walls and water infiltrations into dwellings and provoke the severe deformation of the windows' frames and, hereafter, problems with its opening. Beyond this the vertical wall-corner cracks are a consequence of a wrong procedure performed with the cut of the bricks. Regarding the horizontal lintel cr

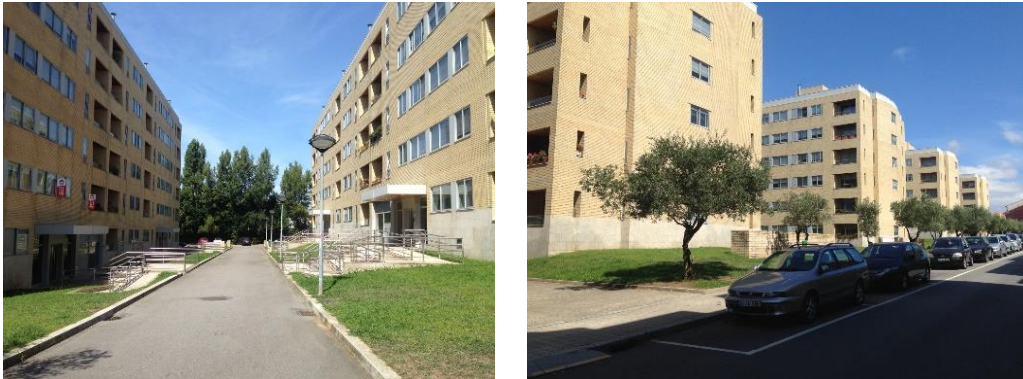
Figure 2. General view of the façades.

The buildings walls are made of two rows of bricks, the external row corresponds to the façade - “brick façade” (Figure 2).

The mortars joints between the brick façades are reentrant relative to the external facing.

Some of the vertical joints have lack of mortar fill, possibly for drainage and ventilation of the wall air-chamber.

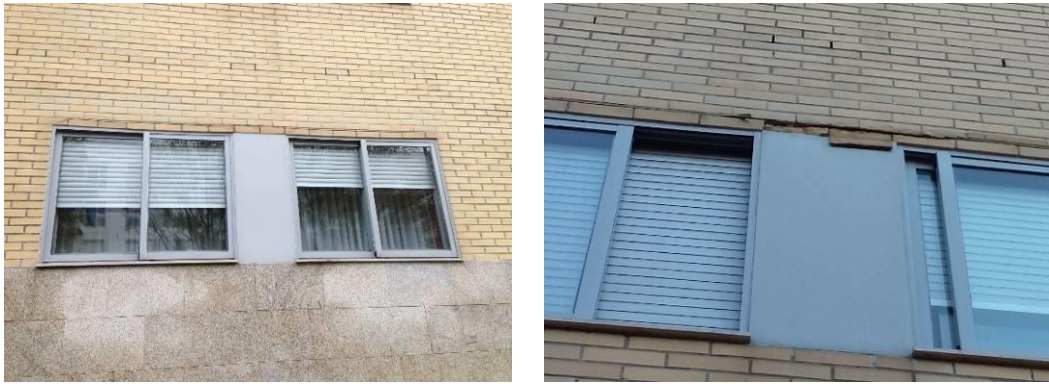
The most serious anomaly occurs as a result of bad conception, or construction mistakes, of the windows lintels.

In some windows opening, due to the lintel deformation, an evident degradation was observed (Figure 3), with infiltrations of water between the frames and the glazed area of the windows, mainly in the windows facing west, note that in Oporto is the side of the sea and from where the wind blows.

Figure 3. Horizontal cracks of the lintels.

All the lintels that present decay and significative cracking should be demolished and substituted by new similar bricks cladding and should be fixed to the existent structure.

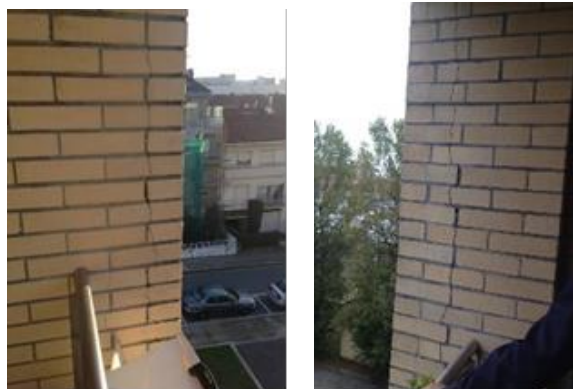
This anomaly is a consequence of a poor connection of the bricks coating to the existing pillars of the wall-corners balconies and is caused by the differences of the building thermal movements (Figure 4).

Figure 4. Vertical cracks of the brick wall-corners balconies.

The rehabilitation of this type of anomalies starts with the demolition of all the cracked bricks and contiguous zone, the strengthening with “HeliBars” in “L” shape and, finally, the reapplication of the bricks with an application of mortar to seal the joints (Figure 7).

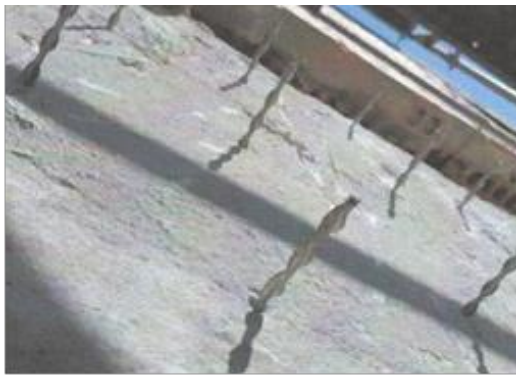
Figure 5. Bottom view of the support of the exterior coating of the masonry double wall.

After the brick removal, between the windows aperture area and the top of the level of the overlying layer of the concrete slabs, the following procedures shall be executed: application of the stainless steel “Pach Pin” (Tramo 2019), application of a strong wire-mesh (stainless or galvanized steel), then reprofile with structural mortar and finally the application of the ceramic bricks and the close of the joints (Figures 5 and 6).

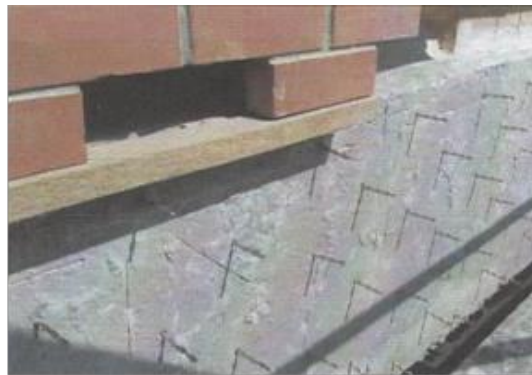
Figure 6. Mesh of mechanical pinning and remedial tying system “DryFix”.

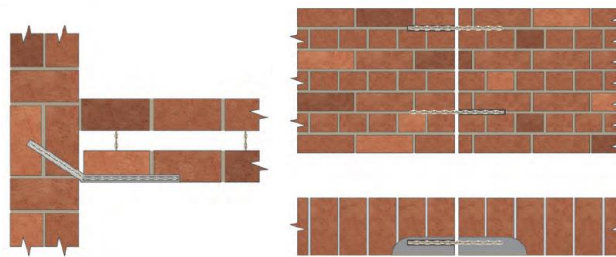
Figure 7. HeliBar stainless steel helical bars (creation of remedial movement joints).

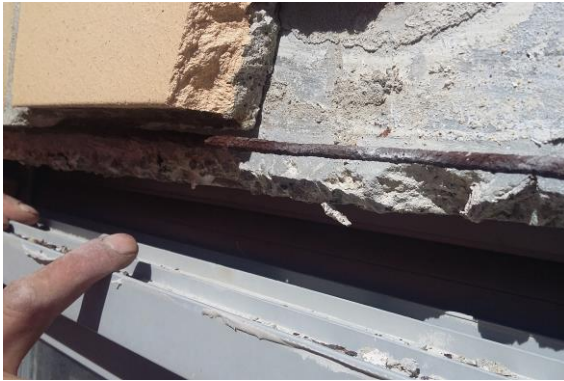
After the demolition of the brick wall, it was verified the existence of an iron rod and shall have been the oxidation of the iron rod that have caused the cracks (Figure 8).

A study to the non-cracked lintels has been done and it has been verified that those, non-cracked, do not have the iron rod.

Figure 8. Existent iron rod in cracked lintels.

Since the cracks are related with the corrosion of the metal rod and not to the deficient support of the brick-façade, it has been decided to demolish the existent surface, remove the iron rod and apply an Aisi 315 steel plate of 1.5 m, fixed to the roller-blind box that will serve as seating base for the demolished surface (Figure 9).

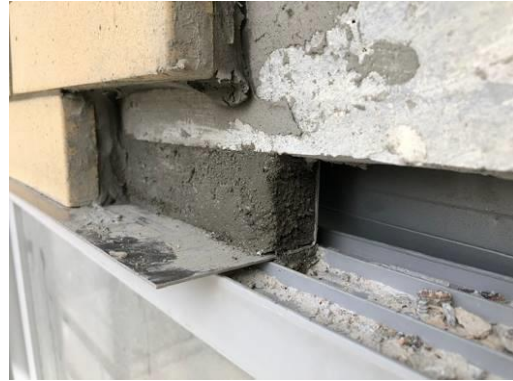
Figure 9. During the rehabilitation work.

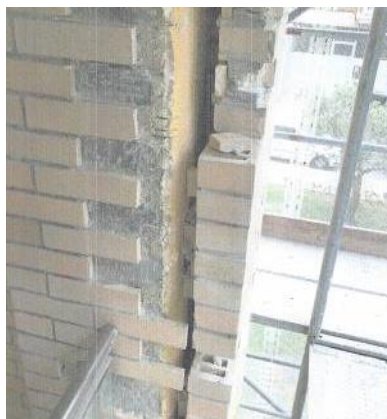
After starting the demolition of the cracked bricks, it has been verified that cracking occurs in the area where the bricks were cut in order to fit into the pillars. The abrupt change of section-brick is the main cause for cracking (Figure 10). It also was verified that in other areas where the complete brick passes in the front of the pillars there is no cracking anomalies.

Figure 10. During rehabilitation work.

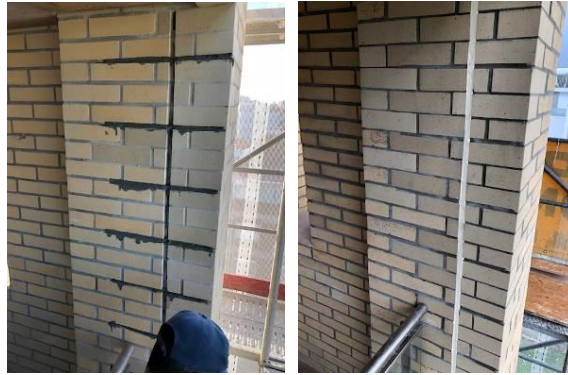
Figure 11. During (left) and at the end of the work (right).

It has been decided to execute an expansion joint, to substitute the “L” rod format by helical bars “Helifix movement joints”, every 3 rows, and to apply a simple rod DryFix on the orthogonal face, which function will be to limit/reduce the building movements, since the new expansion joint removes the existing clamping of the wall (Figure 11).
