BASAL STUDY ON SIMPLE THICKNESS EVALUATION FOR ROAD-LIGHTING POLES WITH LOCAL CORROSION NEAR THE BASEPLATE

TOMOHIRO MITSUNAGA¹, TATSUMASA KAITA¹, and KATASHI FUJII²

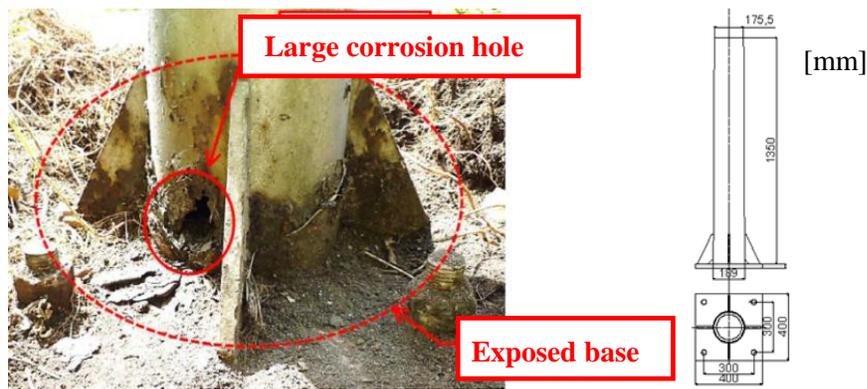
Photo 1. In-situ condition and dimensions of road-lighting pole specimen.

The corroded pole specimen in this study is a dismantled road-lighting pole, which had been used for about 40 years at coastwise road in Yamaguchi prefecture, with severe local corrosion near the baseplate. Photo 1 shows in-use condition and dimensions of this specimen. This pole has 4 stiffening ribs ($t = 12$ mm) on a baseplate, but this baseplate was covered with many clod and weed. The distance from coast of Seto Inland Sea was only 100 m. In Photo 1, a large corrosion hole between 2 ribs could be confirmed near the baseplate. The initial thickness (t_0) of this pole would be 4.5 mm.

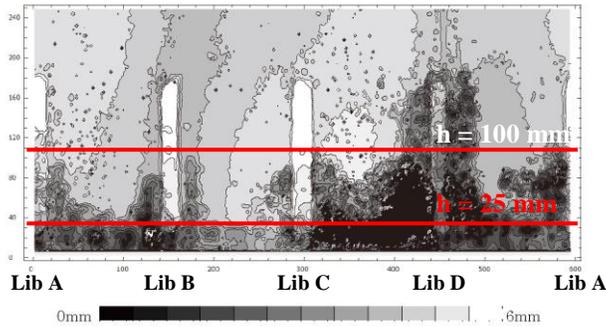
Figure 1. Thickness contour map (3D scanner).

near the baseplate under $h < 75$ mm. Especially, a large corrosion hole between Rib C and D is marked, since both ribs were in a direction towards seaside while in use.

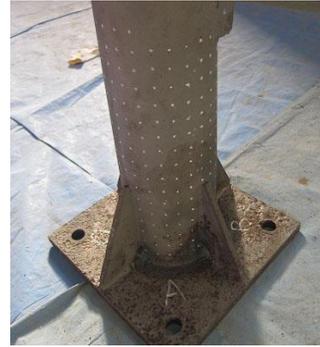
Photo 2. Measuring points for UTG.

On the other hand, UTG measurement was carried out without smoothing process around measuring points at 25 mm mesh as shown in Photo 2. The circular contact probe ($\phi 9$ mm, ultrasonic velocity: 5,920 m/sec, frequency: 5 MHz, measurement accuracy: 10 μ m) and pipe measurement jig were applied for this measurement.

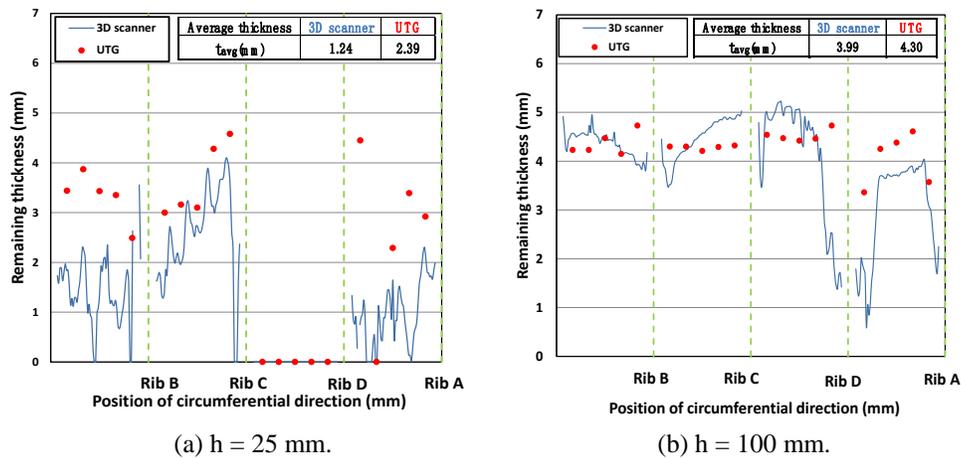
Figure 2. Remaining thickness distributions in a cross-section.

Figure 2 shows the examples of remaining thickness distribution obtained from 3D scanner and UTG measurement results in a cross-section of $h = 25$ mm and 100 mm. The number of measuring points per one cross-section are 254 (3D scanner) and 20 (UTG), respectively. In Figure 2(a), it could be noticed that the UTG results (red dots) are greater than that of 3D scanner. And, the average thickness calculated from UTG

results was overestimated about 1.15 mm than actual thickness. However, in the $h = 100$ mm section, which has minor corrosion as compared to the section of $h = 25$ mm, the measuring results obtained from 2 different devices significantly approximated each other, as shown in Figure 2(b). From these facts, it is thought that overestimation of remaining thickness in UTG measurement was caused by surface roughness due to severe local corrosion. In addition, the average thickness and thickness distributions of 3D scanner and UTG are almost the same at the section in the range of $h > 100$ mm.

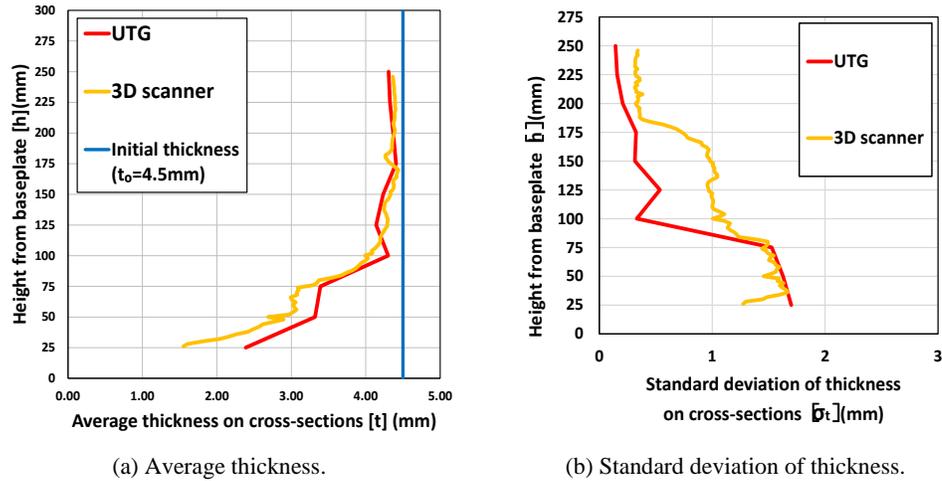
Figure 3. Relationship between h and statistical thickness parameters.

Figure 3 shows the relationship between h and statistical thickness parameters. From Figure (a), the average thickness (t_{avg}) in a cross-section was decreased remarkably in the range of $h < 75$ mm. In this portion, it is thought that the clod and salty weed on baseplate would accelerate corrosion progress. And, it can be confirmed that the UTG measurement is more likely to overestimate remaining thickness when the height from baseplate is smaller. Figure (b) shows the relationship between h and standard deviation of thickness (σ_t). In the range of $h > 75$ mm, because many pitting corrosion which has the diameter smaller than that of UTG probe are distributed widely on steel surfaces, UTG probe cannot measure the corrosion wastage by their pitting corrosion. Therefore, σ_t of UTG results will become smaller than that of 3D scanner. On the other hand, in the range of $25 \text{ mm} < h < 75$ mm, because the large corrosion pits, which may affect to the average thickness, are generated all over the surface, it can be thought that the variation of measured thickness is a little more than 3D scanner.
