CORROSION BEHAVIOR OF FRICTION PLATE SURFACES CONNECTED BY HIGH-STRENGTH BOLTS

The aim of this study is to examine the corrosion behavior of friction plate surfaces connected by high-strength bolts under severely corrosive environments in steel bridge structures. The corrosion behavior was inspected using corroded specimens cut from a steel girder bridge that collapsed after severe corrosion for 28 years. Visual inspection and measurement of the corrosion thicknesses of the inner surfaces were performed. The arithmetic average roughness was also measured to evaluate the friction coefficient. From these investigations, it may be clear that the aging deterioration of the friction surfaces of joint plates connected by high-strength bolts is has little influence over the slip strength. The details of conducting investigations and their results are presented in this paper.

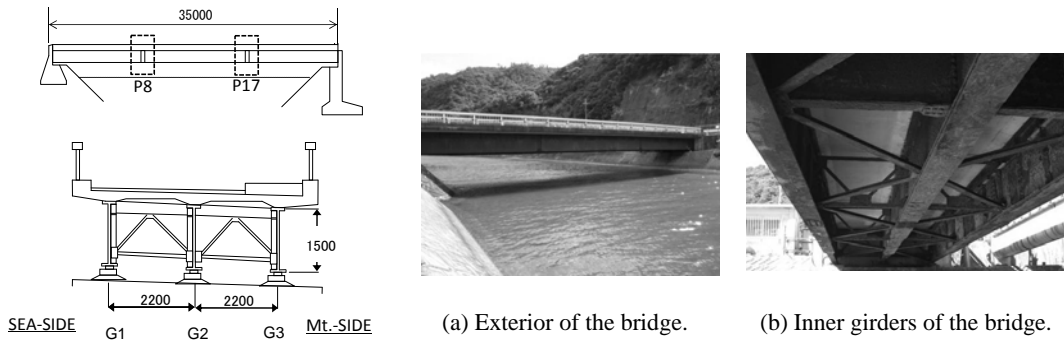
Fig. 1 shows the steel girder bridge before its collapse. This bridge was fabricated from weathering steel left unpainted, and had three girders with 1500mm girder depth, 2200mm distance between each girder, and 35.0m span. The bridge had been exposed to environmental conditions 50m from the seashore in Okinawa for 28 years, and had been monitored on its corrosive environment and corrosion profiles until its collapse in 2009 due to the severe corrosion of the girder end. It can be seen from the figure that the inner girders in the bridge cross-section are corroded more than the outside girders.

Figure 1. Inspection steel girder bridge.

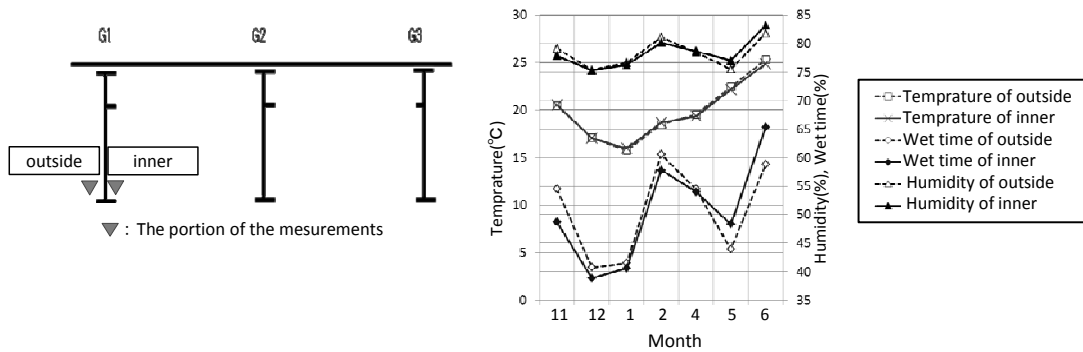
Figure 2. The portion of the measurements. Figure 3. Temperature, wet periods, and humidity.

The monitoring test was conducted to research the corrosive environment around this bridge. Atmospheric temperature and humidity around the bridge are shown in Fig. 3. The figure also shows the rate of wet periods calculated from measuring temperature and humidity. A wet period is defined as a continuous time in a state of humidity of 80% and higher with a temperature of 0°C and higher (ISO 9223). The average monthly temperature is 26.2°C and the humidity is 78.5%. The rate of the wet periods around the bridge was over 60% between February and June.

To determine the chloride levels around the bridge, the dry gauze method was conducted in accordance with Japan Industrial Standards (JIS Z 2381). Fig. 4 shows the amount of aerosol chlorides measured during every month. The average of aerosol chlorides in every month was 1.9mdd (mg/dm²/day). It is over the limit value (0.05mdd) to be able to construct a weathering steel girder bridge unpainted, as per Japanese design standards.

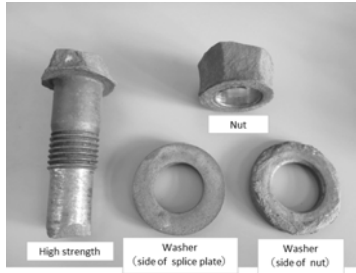
Corroded friction joints connected by high-strength bolts were cut from the web plates of the outer main girders, i.e., G1 and G3, as shown in Fig. 1. Fig. 4 shows the corroded high strength bolts which were removed with the core extraction method from the corroded friction joint. The thickness-reduced quantities of the bolt heads and nuts exposed to corrosive factors (e.g., air, aerosol chlorides, and rain water) were severely intense. The washers were also severely corroded except the surfaces in contact with a bolt head and a nut. On the other hand, the bolt shaft parts sealed by a bolt hole have comparatively maintained their integrity.

Figure 4. High strength bolts.

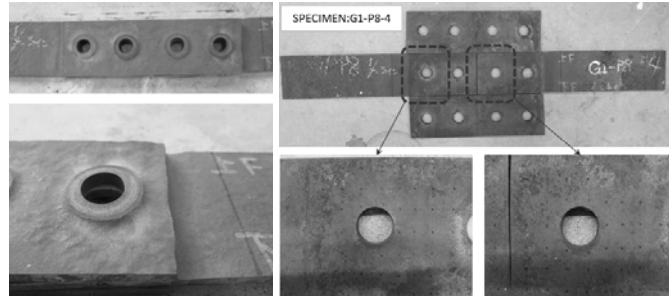
Fig. 5 shows the corrosion states of the splice plates. It can be seen that the surfaces of the splice plate are uneven due to the corrosion thinning. However, the progression of the corrosion at the surfaces of the splice plate in contact with washers is inhibited. On the other hand, the corrosion of the surfaces around washers have severely progressed in a doughnut-shape with an approximate 10mm width. Furthermore, the end edges of the fastener plates also have progressed with the corrosion thinning. It can be said from this corrosion profile that the joint parts on the edges of the fastener plates and around washers are more corroded because those parts present a condensed condition with dust and water.

Fig. 6 shows the corrosion aspect of the inner surfaces of the fastener plate. The intense rust can be seen at the edges of inner surfaces of the fastener plate more than the inner surfaces around the bolt holes.

Figure 5. Splice plates.

Figure 6. Inner surfaces.

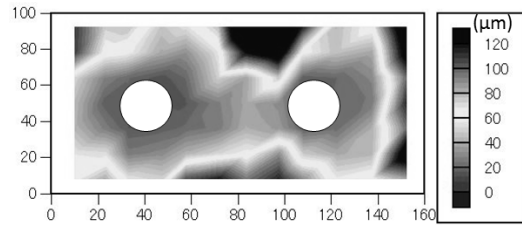
Corrosion thicknesses were measured at every 10mm on the inner surfaces of the fastener plate with an electromagnetic thickness gage, as shown in Fig. 7. The thickness of corrosion shown is the average value of the triple measurements. The corrosion thicknesses of inner surfaces of the fastener plate are shown in Fig. 8. From this figure, it can be seen that the edges of the inner surfaces are more rusted than the

inner surfaces around a bolt hole. These results show that the progression of the corrosion at the inner surfaces around the bolt hole is inhibited by the tensile force given by the high-strength bolts.

Figure 8. The corrosion thickness.

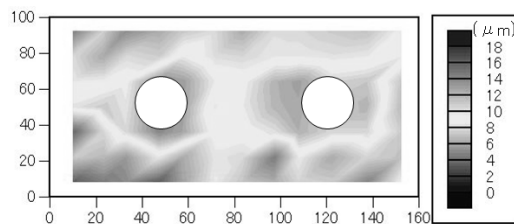
The roughness of the inner surfaces of the fastener plates was measured with a tracer-type surface roughness meter. The arithmetic average roughness (i.e., R_a) that has a relationship with the friction coefficient was applied for this measurement. Fig. 10 shows the contour plots of the arithmetic roughness of the inner surfaces. It can be seen clearly that the edge of the inner surfaces had more roughness than the inner surfaces around the bolt hole, because of the intense rust.

Figure 10. The arithmetic average roughness.

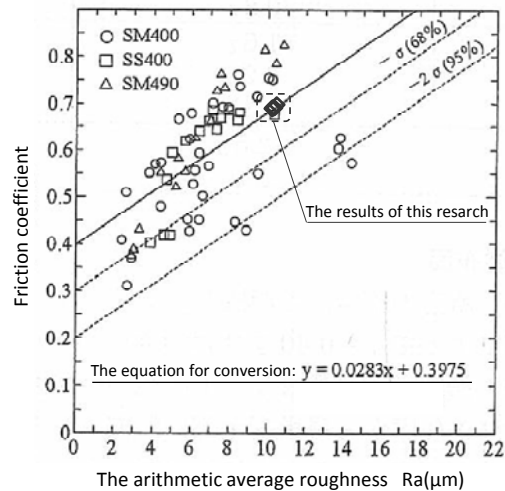
The friction coefficients of the inner faces of test specimens were evaluated with their arithmetic average roughness measured. The edge of the inner surfaces had intense rust. Therefore, the arithmetic average roughness of the inner surface of specimen at a distance 30mm away from the bolt hole was used for the evaluation. The evaluation was performed using an established transformation method (Minami et al. 2004.). The previous transformation data and equation for the evaluation are shown in Fig. 11.

Table 1 shows the evaluated friction coefficients and the used arithmetic average roughness for the test specimens. These data are also shown in Fig. 11 for comparison purposes. All values of the coefficients show high friction coefficients over 0.6. In terms of arithmetic average roughnesses, there was a dispersion in the measured data. However, it seems that the friction coefficient of the corroded high-strength grip bolted joint parts satisfies the design value, which is 0.4, sufficiently.

Figure 11. The relationship between Ra and the friction coefficient.
