# **ANALYSIS OF DETERIORATION IN REINFORCED CONCRETE BRIDGE GIRDERS DAMAGED BY CHLORIDE DETERIORATION AND FATIGUE**

H. HONDA, T. SHIMOZATO, and Y. ARIZUMI

*Dept of Engineering, Ryukyu University, Okinawa, Japan*

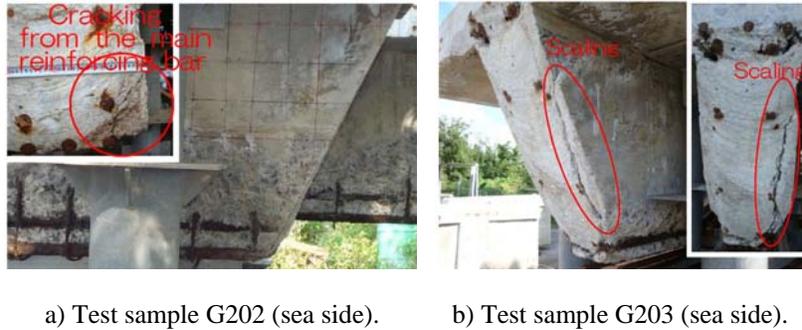
Figure 2. State of damage in girder G2 (sea side).

- On the undersides of the main girders, cover concrete had spalled off, leaving the main reinforcing bars exposed and severely corroded. On the sides, spalling had not gone beyond areas around the main reinforcing bars.

- There was extensive scaling accompanied by cracking on the sea side of the main girder, exposing main reinforcing bars as far as the second layer, resulting in extreme corrosion. On the mountain side, only the lowest layer of reinforcing bar was affected.

Next, Figure 2 shows the cross section of girder G2 close to the sea side, and Figure 3 is a diagram of cracking in main girders. The net cover over the main reinforcing bars was 54 mm on the underside and 69 mm on the sides, so the underside had the least cover. Cracking on the sea side of test sample G202 penetrated to the web face close to the second layer of main reinforcing bar, but had not advanced above that (Figure 3c). The cut surface at the midpoint between supports had some remaining cover concrete, with cracking observed to penetrate from the lowest main reinforcing bar layer, pass close to the second layer of main reinforcing bar, and extend to the surface. Thus, cracking had not originated from the second layer of reinforcing bars.

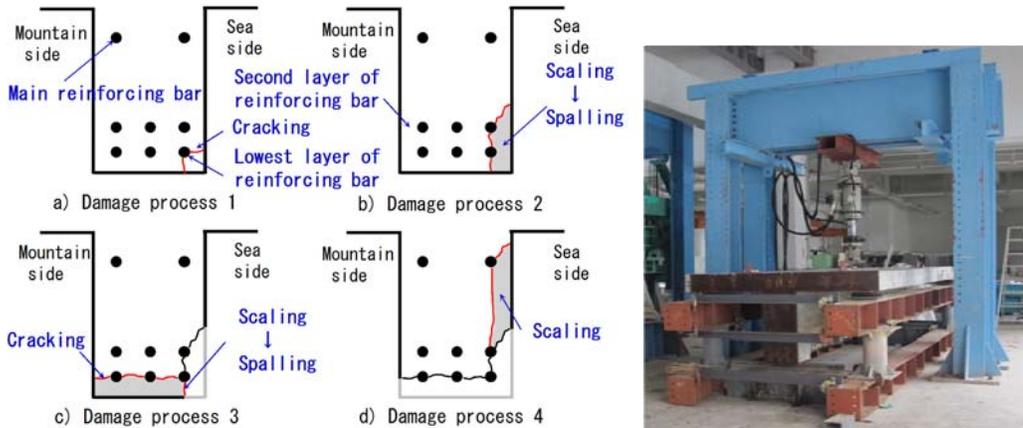
Figure 3. Cracking damage process in main girders.

Cracking on the sea side of test sample G203 penetrated to the web face close to the main reinforcing bars, and to the surface close to the center of the web (Figure 3d). Thus, close to the main reinforcing bar, damage had penetrated from the lowest layer of main reinforcing bars to the second layer, and advanced gradually from the depth of

cover over the stirrups at the center of the web to the surface. The net cover from the sides to reinforcing bars was around 85 mm in test sample G202, but only around 65 mm in G203, in a position 20 mm thinner.

From the above, the state of deterioration can be illustrated as in Figure 3 for the undersides and sides of main girders, and for the sea sides and mountain sides, in which different damage patterns were observed. The following characteristics of chloride-induced deterioration can be inferred.

- Corrosion and expansion from the lowest layer of main reinforcing bars on the sea side caused cracking, and vertical cracks had extended on surfaces with thinner cover. (Figure 3a)
- Reinforcing bar corrosion advanced further due to windblown salt, and cracking extended from the second layer of main reinforcing bars to the web.
- Cover concrete on the sides spalled off (Figure 3b) and main reinforcing bar on the mountain side corroded due to contact with windblown salt. Cover concrete spalled off the underside. (Figure 3c)

- On the sea side, corrosion of the stirrups caused cracking to advance onto the upper web; there was scaling of the cover concrete. (Figure 3d)

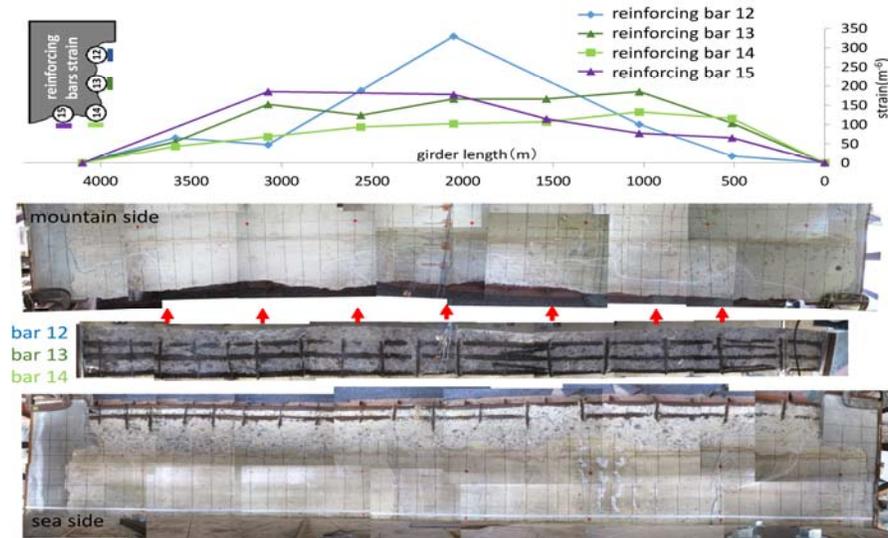
Figure 6. Reinforcing bars strain and the state of deterioration.

Figure 6 shows reinforcing bars strain after 3.5 million times loading. In addition, for comparison of the state of deterioration and reinforcing bars strain, photos of test sample G202 is to be displayed. As Figure 6 shows, reinforcing bar 12 of the mountain side was one point concentrated load loading state of simple beam. Other reinforcing bars did not show a tendency of the “reinforcing bar 12”. Reason as, reinforcing bar 12 that remain of side of the cover concrete are integrated concrete and reinforcing bars. The state of deterioration, such as cracks and reinforcing bars strain is not related.
