ROAD SAFETY AUDIT: A CASE STUDY

2.2 The Case Study Road

For the application of the selected methodology through a case study implementation on Nigeria Roads, a 50 km section of Kano-Kaduna express way has been selected. This road section is a part of a dual carriageway road which connects two major cities having high populations in Nigeria and also many towns that have been located along the same road section.

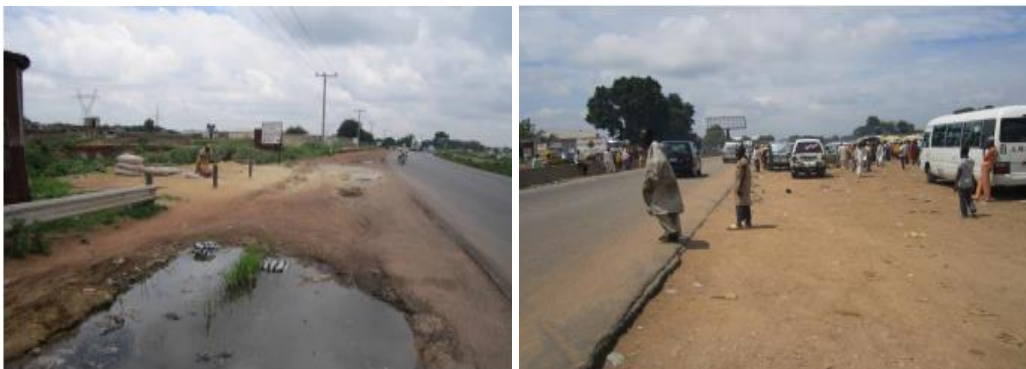
The most common and dangerous hazards which were observed and classified are dangerous fixed objects on roadside, missing shoulder, improper junction design, potholes, improper commercial activities layouts on road sides, improper bus stop locations, dangerous median openings, edge deterioration and missing signs. Majority of these hazards were associated with the road side safety.

Figure 1. Some samples from observed hazardous features along the studied road sections.
