# INVESTIGATION OF DAMAGE ON DERBENDIKHAN DAM DURING EARTHQUAKE EXCITATION

CAGRI MOLLAMAHMUTOGLU<sup>1</sup> and IDRIS BEDIRHANOGLU<sup>2</sup>

In this study, the performance of a damaged dam was evaluated through a three-dimensional finite element model. The dam is located in Derbendikhan city of Northern Iraq and damaged during a 7.3 magnitude earthquake which was happened 30 kilometers south of Halabja city. Derbendikhan dam which was built between the years 1956-1961 is a clay-core rock fill dam. The damage of the dam was investigated at the site right after the earthquake and some cracks were observed in the main body of the dam. The main goal of this work is to present the results of the survey which was conducted at the site and investigating the damage development mechanism through a realistic three-dimensional finite element model of the dam. As complying with the observations at the site, the finite element analysis has shown that the primary failure mechanism is due to the separation of the core and rock fill sections at the downstream side of the dam.

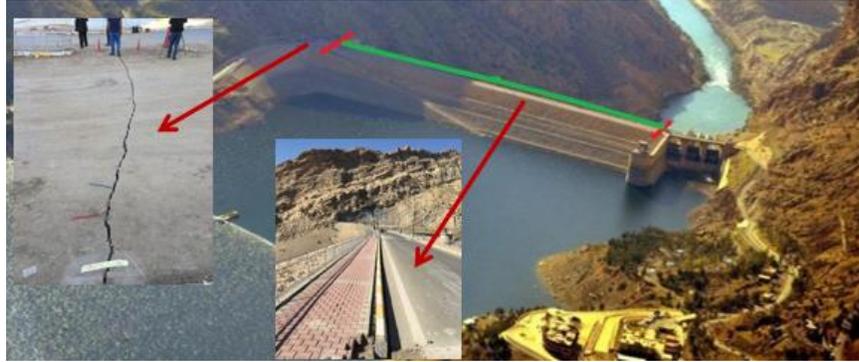
The earthquake focused in this study occurred on 12.11.2007 at UTC 18:18:17 (21:18:17 local time) at 30 Km south of the city of Halabja, Suleymaniyah/Iraq on the Bitlis-Zagros rupture zone near Iraq-Iran border. The faults of the rupture zone caused an earthquake with a magnitude of 7.3 Mw. Due to the first announcement by USGS, the epicenter is located at 34.957°N 45.792°E with a depth of 25 km. Later the location is revised as farther to east 34.905°N 45.956°E and the depth is revised as 19 km. Thus the territorial address of the epicenter was shifted from Suleymaniyah/Iraq to Kermanshah/Iran. The earthquake was felt in a vast region and caused major damage to the dam structure. A prominent crack running through the span of the dam is visible on the crest of the dam as can be seen in Figure 2. This crack is on the downstream side and reaches up to 30 cm in the middle. Moreover, end cracks appeared on both sides of the dam.

These findings suggest rocking of the entire dam body along the stream direction and resulting separation of the core and filling sections. Also, a depression occurred on the downstream side of the crest.

Figure 2. Lateral downstream crack (green) and end cracks (red) occurred on Derbendikhan dam structure during the earthquake.

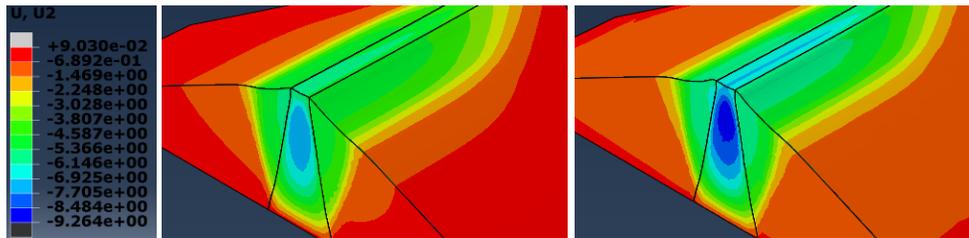
Analysis results are reasonable with the field observations (Figure 2). Figure 7 shows the vertical displacement field before (left) and after (right) the earthquake. It is seen that due to self-weight,

Figure 7. Vertical displacement (m) field before (left) and after the (right) earthquake.

consolidation type settling occurs and as observed in the field an additional depression around 1 m occurs around the crest region after the earthquake.

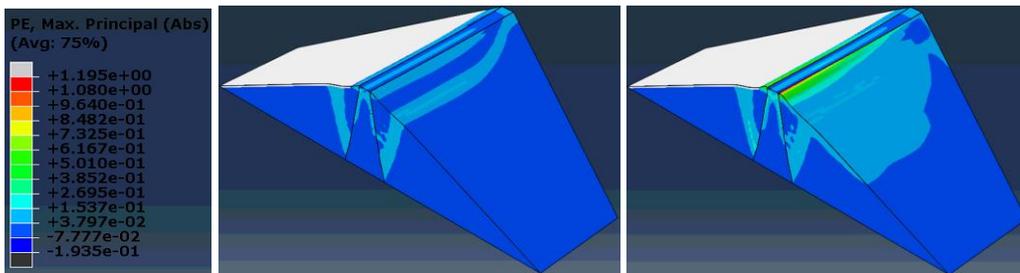
Figure 8. Absolute values of max principal plastic strains before (left) and after (right) earthquake.

In plastic analysis, a measure of the concentration of max plastic strains can be assumed as probable fault (crack) zones. Figure 8 shows the absolute value of max plastic strains which also indicates the end slip bands which manifested as end cracks and the lateral downstream crack running along the length. Mohr-Coulomb material model seems to be reasonable when elaborate data on material parameters are not available. As it is seen that this simple nonlinear material model with assumed parameters and partly assumed dimensions are able to capture the observed damage mechanism. Thus we can conclude a possible separation of the core and rock fill sections which is prominent at the downstream side. The water pressure seems to limit the separation on the upstream side. Overall the damage mechanism fits with the on-site outer observations. Thus it can be concluded that the dam structure is non-negligibly damaged and care must be taken.
