ANALYSIS OF HAGIA SOPHIA USING NONDESTRUCTIVE MESUREMENT

TAKASHI HARA¹ and KENICHIRO HIDAKA²

In this paper, the structural behavior of Hagia Sophia was analyzed by use of vibration records of the structure. The vibration records were measured by the micro tremor meters. The recorded data was utilized not only to define the mode shape but also to evaluate the structural problems. Firstly, the vibration characteristics of the main building were analyzed by combining the vibration records. Secondary, the deformation characteristics and the structural functions of the second cornice were investigated in the same manner as the main building. In case of main building, from the frequency domain analyses, the natural frequency of the main building was analyzed and the obtained natural frequencies were compared with the results of the previous researches. The vibration modes were investigated as well. From these results, the characteristics of the total structure were clarified and the structural problems were detected. In case of the second cornice, the base at the corner where was the junction of the main pier and the sub-dome connecting to the semi-dome showed the movement of the embed

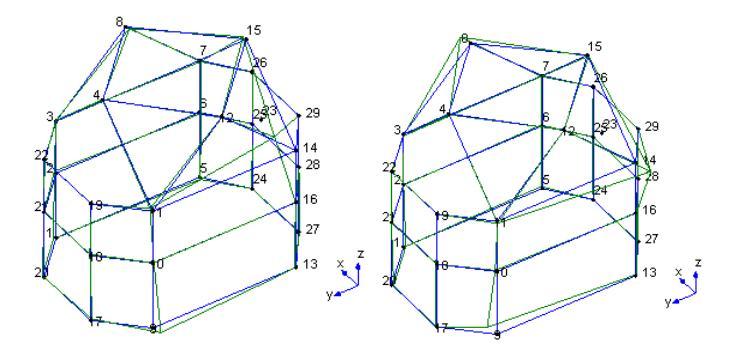
Using the FDD analysis, the frequency domain expressions of four measuring record sets were combined and represented. From the measurement, the first two frequencies 1.85Hz and 2.09Hz were obtained. These were the same results obtained by Hidaka (2004) and Çakmak (1995). 1.85Hz and 2.09Hz are natural frequency for the predominant vibration in N-S direction, respectively. However, in addition, in this analysis, the peak frequencies 2.93Hz and 3.06Hz, were obtained respectively. The vibration modes of 2.93Hz is shown in Figures 5. In case, the building at south west pier moves, even it is a column base. Çukmak (1995) reported that the southern portion of the building has deeper foundation than the northern portion. It may cause the column movement mode.

Figure 5. Vibration mode shape (2.93Hz).

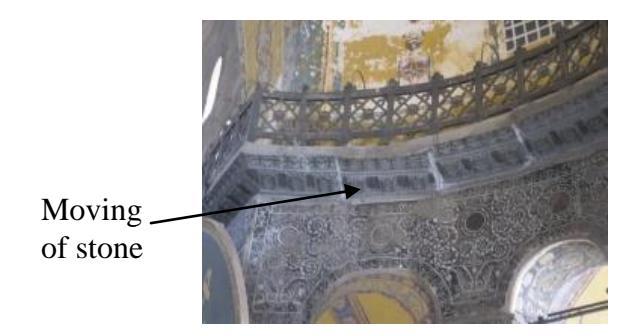
Figure 6. Problems at the south west second cornice.

In Hagia Sophia, there is the main dome at the center and the main dome is supported on four main arches. Two arches are supported by the buttress in northern southern direction. Also, other arches are supported by the semi-domes in eastern western direction. Each semi-dome has two sub-domes. The second cornice is attached to the sub-dome placed on the exedra. At the eastern corner on the south west cornice (see Figure 6), the deformation of the second cornice and the movement of the composing stones were detected. From the observation, the same phenomena were detected at each corner of the second cornice on the main piers. There are particular deformations. Therefore, the movement of the cornice at south west corner was investigated as an example. Figure 6 shows the picture of the problem of the south western cornice.

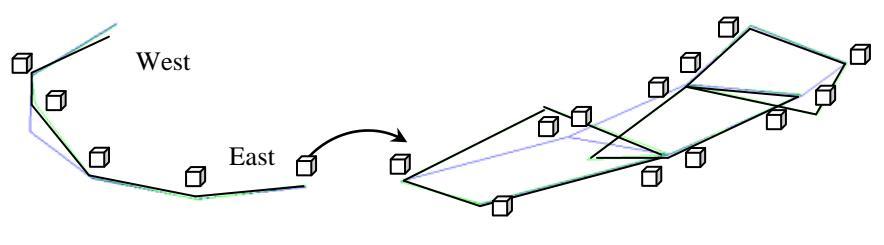
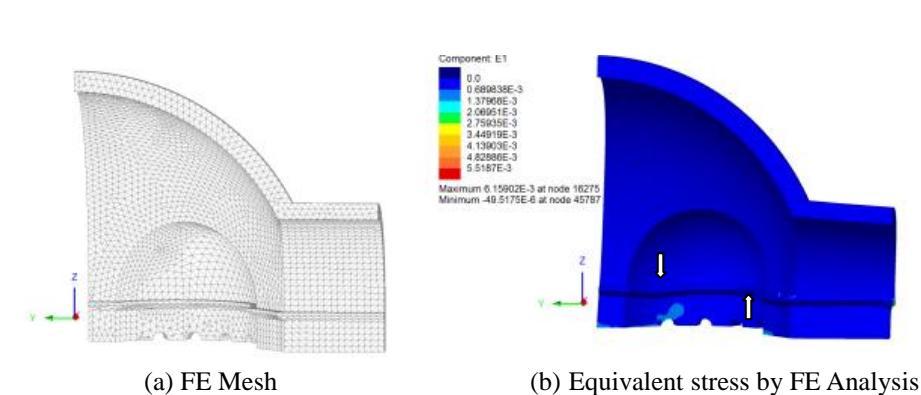
Figure 7. Vibration of second cornice (\square tremor meter).

The total movement of the cornice shows large amplitude at the center with the natural frequency 9.70Hz (Figure 7(a)). Also, at the east end of the south west cornice, three stones vibrate independently with natural frequency 2.91Hz (Figure 7(b)). The movement of the stones was detected at the east end of the south west cornice.

(a) Total vibration (b) Brick vibration at east
