STATE OF THE ART IN REPAIR AND STRENGTHENING METHODS OF DETERIORATED CONCRETE BRIDGE STRUCTURES

This paper summarizes the current development for repairing and strengthening deteriorated concrete bridge structures in Japan, especially those deteriorated due to alkali-silica reaction (ASR) and chloride attack. Generally, surface treatments are applied as the repair method due to ASR and chloride attack. Barrier coating and penetrating sealer are two methods that are actively applied as surface treatments in Japan. An investigation of repaired concrete bridge structures using these methods indicate that acrylic-based surface coatings are the most suitable method for repairing concrete structures, and the silicon-based compounds repair concrete structures with low risk of corrosion. Furthermore, the use of sodium or potassium for silicate-based surface treatments should be avoided, as these solutions may exacerbate ASR. This finding was backed up by an accelerated mortar bar test experiment under a modified ASTM C1260 test method. The results show that large ASR expansion occurred on mortar bars immersed in sodium silicate solution (Na_2SiO_3). In regards to strengthening, CFRP sheet

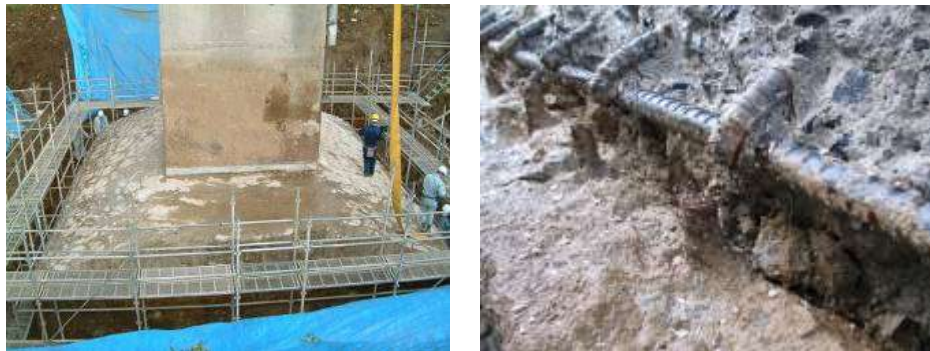
Figure 1. Fracture of rebars and surface cracking on the footing of a bridge.

In the Hokuriku region of Japan, ASR-affected PC bridges appeared from the 1980s. Serious ASR problems involving fractures of the reinforcing bar (rebars) were found on the Noto Expressway and National Highway Route 249. As shown in Figure 1, fracture of rebars and surface cracking occur especially on the footing of bridge piers. In addition, in Toyama Prefecture, deterioration due to ASR was observed in bridge structures built between the 1960s and the 1970s (Daidai *et al.* 2012).

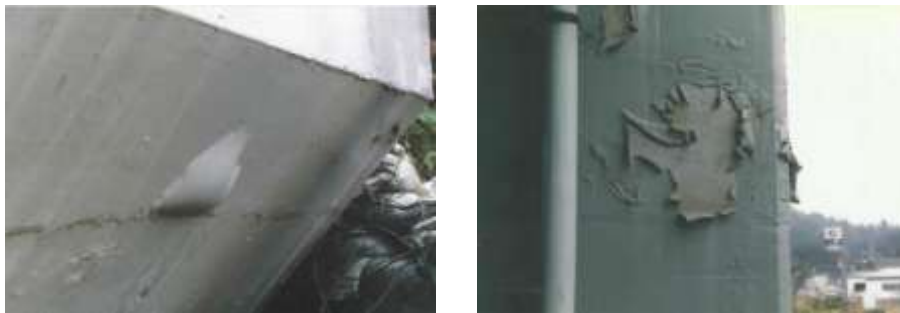
Figure 2. Breaking of the epoxy coating due to trapped residual water.

There are at least three surface coatings materials that are actively applied in Japan: acrylic, urethane, and epoxy. In the case of low-ASR potential, Nomura *et al.* (2013) reported that acrylic fiber-sheet coating was effective, while urethane continuous-fiber sheet performed well in the case of high ASR potential. These field investigation results are in agreement with laboratory studies conducted by Hamada *et al.* (2004). Based on the Hamada experiment study, an efficient acrylic fiber-sheet coating, protective against ASR expansion, can significantly enhance the structural behavior of ASR-affected beams undergoing sustained loading. This coating is also believed to give protection against chloride attack. In contrast, the applicability of epoxy-based surface coating was difficult for repairing ASR-affected structures. Daidai *et al.* (2012) investigated ASR-affected bridge piers in Toyama Prefecture that had been repaired using epoxy coating. It was observed that the repaired sections were more damaged and fully covered with cracks than the unrepaired ones, indicating that the repairs actually promoted ASR. There is concern that this surface treatment will trap residual water, thus triggering ASR. In addition, as shown by Figure 2, water trapped inside the epoxy coating will freeze during the winter season, and easily break the coating.

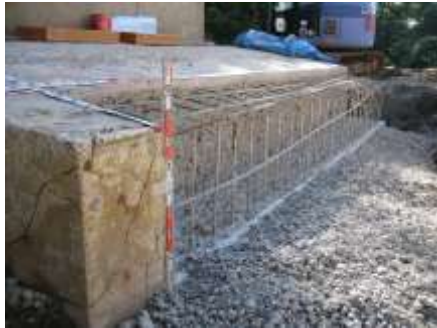
Figure 3. Partial reconstruction of bridge footing with fracture of rebars.

Severe deterioration, due to natural disasters, ASR, or chloride attack, will cause structural degradation, such as loss of load-bearing capacity. Thus, the deteriorated bridge structures cannot be repaired with the surface-treatment method. As shown by Figure 3, the structure must be partially or even fully reconstructed. In addition, in some cases, the strengthening method should also be applied to restore or even increase its load-bearing capacity. The strengthening methods commonly used in Japan include CFRP sheet bonding, concrete jacketing, and PC-confined methods.

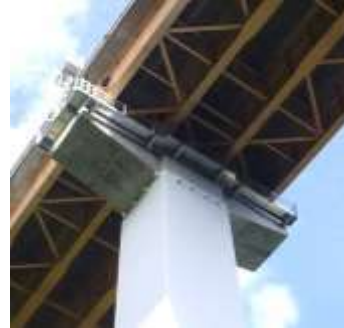
Figure 4. Strengthening of column by steel plate jacketing.

In Toyama Prefecture, two PC structures repaired with concrete jacketing were showing different results (Nomura *et al.* 2013). In structures with high residual expansivity, at repair time the concrete-jacketing method was effective enough in suppressing ASR expansion. On the other hand, in structures where residual expansivity has been constant, cracks still occurred after repair. In this case, since ASR was not trending toward convergence, it was considered that concrete jacketing was not that effective in ASR suppression. However, one way to effectively suppress the ASR using this method is by increasing the margin of the reinforcement-steel diameter. As shown by Figure 4, in addition to the ordinary concrete jacketing, the steel-plate jacketing method is also being used. However, this method is more complicated and considered to be more costly than ordinary concrete jacketing.

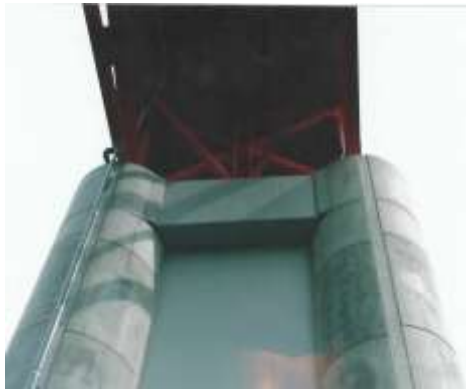
Figure 5. Strengthening of column by immersed PC confined method.

Restoring structural performance of ASR-affected structures in Japan has also been done by a PC-confined method with prestressing steel wire (Torii *et al.* 2000) (Figure 5). This method has been successfully applied on ASR-affected reinforced concrete piers of the Toyokawa Bridge, Ishikawa Prefecture. Two years of monitoring also have shown that the prestressing forces around the existing RC piers effectively controls the extension of ASR cracks and the expansion of concrete. In 2006, this technique was also reported to be effective in controlling crack development and ASR expansion on ASR-affected bridge piers in Toyama Prefecture (Torii and Daidai 2006).

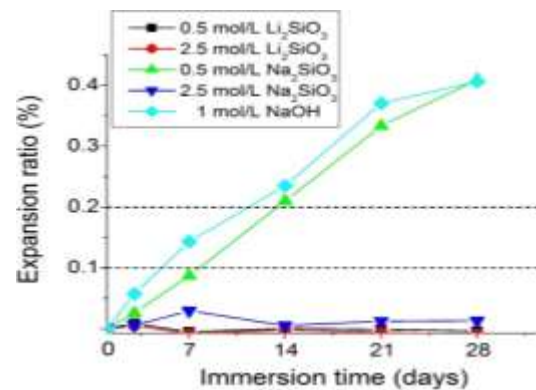
Figure 6. Expansion ratio of mortar bars in 0.5 mol/L and 2.5 mol/L Na_2SiO_3 and Li_2SiO_3 solutions (Prasetia *et al.* 2013).

Previous research was conducted to investigate the ASR mitigation effect of Na_2SiO_3 and Li_2SiO_3 solutions (Prasetia *et al.* 2013). The accelerated mortar bar test was conducted according to a modified ASTM C1260 method. As shown by Figure 6, the mortar bar specimens immersed in Li_2SiO_3 solution did not expand at all, which suggests no ASR occurrence. In contrast, in the case of Na_2SiO_3 solution, specimens immersed in 0.5 mol/L solution revealed a large expansion. This might be evidence that Na_2SiO_3 actually triggers ASR. However, in the case of the specimens immersed in 2.5 mol/L solution, an early low expansion was observed up to 7 days, but this expansion subsequently vanished. It seems that as the steady supply of highly concentrated Na_2SiO_3 from the external source continues, the reaction between Na_2SiO_3 and $\text{Ca}(\text{OH})_2$ takes place and suppress the pace of alkali-silica reaction. Based on these results, the use of Li_2SiO_3 material as a surface treatment method can be recommended for repairing ASR deteriorated concrete structures. Moreover, although Na_2SiO_3 material possesses ASR-suppression properties, it might not be recommended for external supply application unless it is in high concentration.
