# **SHEAR REPAIRED RC BEAM BY FRP BONDING WITH EXTERNAL POST-TENSIONING**

RUMANA CHOUDHURY, T.G. SUNTHARAVAIVEL, and NIRMAL MANDAL

*School of Engineering and Technology, Central Queensland University, Rockhampton,  
Australia*

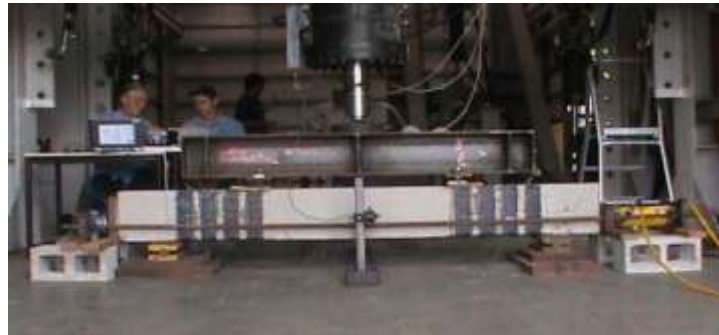
Figure 2 shows the test setup during the final testing procedure. The post-tensioning was applied with eccentricity of 50mm from the center of the beam. Linear Variable Differential Transformer (LVDT) was used to measure vertical deflections of the tested beam specimens at the midpoint location along the beam length.

Figure 2. The test set-up.

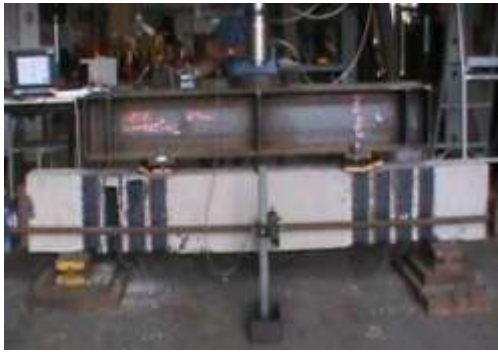
Beam 2 was pre-loaded up to 228 kN vertical load until the appearance of the first shear crack and then the damaged beam was strengthened with two layers of CFRP U-strips. The beam was then tested under the same test set-up but with the addition of the 100 kN external horizontal post-tensioning. The beam failed by debonding of the CFRP strips, followed by concrete shear failure, as can be seen in Figures 3 and 4. The failure load for this beam specimen was 431.3 kN, which was 49.7% higher than the failure load of the control beam. The ultimate deflection at the midpoint of the beam specimen was 26.93 mm.

Figure 3. Failed beam specimen.

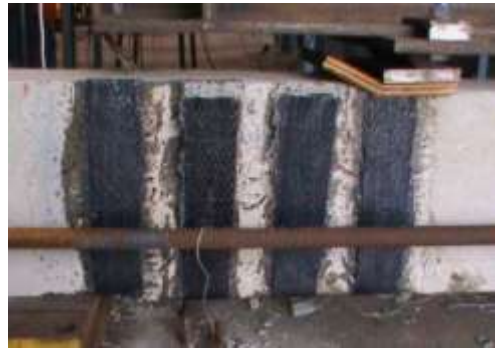
Figure 4. CFRP delamination and shear failure of beam specimen.

Beam 3 was pre-loaded up to 215 kN, then strengthened with two layers of CFRP U-strips and post-tensioned. This beam also failed by CFRP strips debonding, followed by concrete shear failure. The failure load was 372.5 kN, which was 29.4% higher than the control beam's failure load; the ultimate midpoint deflection recorded was 27.59 mm.

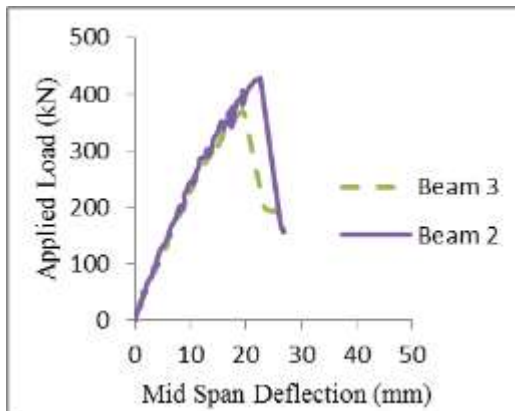
Table 1 summarizes the test results. Figures 5 and 6 illustrate the load deflection diagrams for the tested beam specimens. The behavior of the CFRP strengthened beams can be clearly seen in the figures.

Figure 5. Load-deflection diagram for Beam 2 and Beam 3.

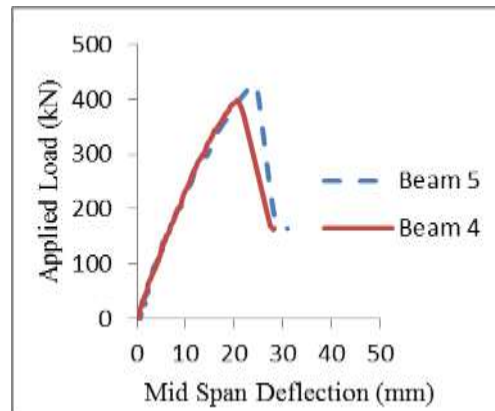
Figure 6. Load-deflection diagram for Beam 4 and Beam 5.

Beam 4 was pre-loaded up to 235 kN and repaired with one layer of CFRP U-strips. Vertical loading was applied along with the horizontal post-tensioning. The beam failed at 399.7 kN in a similar failure mode as before, and the failure load was 38.8% higher compared to the control beam. The ultimate midpoint deflection was 28.45 mm.

Beam 5 was shear strengthened with two layers of CFRP U-strips, and post-tensioned before the load was applied. The beam failed in shear after the CFRP strips debonded from the concrete surface. The ultimate load at failure was 430.4 kN, which was 49.5% higher than that of the control beam. The ultimate midpoint deflection was 31.09 mm.
