PATHOLOGIES AND INTERVENTIONS FOR DEFENSIVE STRUCTURES: THE SAFEGUARD OF ARCHITECTURAL HERITAGE

SILVIA MAZZETTO

School of Architecture and Design, Lebanese American University, Byblos, Lebanon

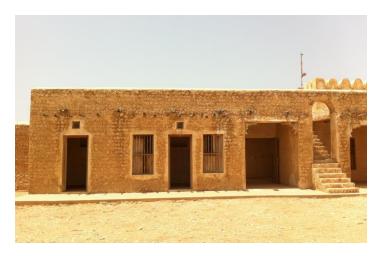
Figure 3. Al Thagab Fort, the external walls are constructed with layers of alternated coral rock and limestone blocks having a regular shape (Source: Author).

Nowadays still the perimeter walls of both the forts consist of alternated layers of coral rock and limestone bocks, having both regular and irregular shapes. Wooden beams construct the structures of the roofs, currently in a good state of conservation in Al Taghab fort (Figure 3) while in Al Rakayat fort they are damaged by deep cracks which generated the failure of extended portions of the ceiling as a consequence of the building's abandonment in the last decades.

In Al Thagab fort, during the last restoration works, the upper level of the external wall was reconstructed using regular blocks of limestone, which are easy to identify if compared with the original lower part, more irregular and fragmented. In both the forts the interventions included newly reconstructions of the perimeter walls due to their structural instability, such walls were left visible in al Taghab fort while being covered with the final plaster in Al Rekyak fort. The cracks still distinguishable in the external walls are probably the result of structural settlement as a consequence of the consolidation and reconstruction works. In both the forts the oldest, an original layer of the wall is located at the bottom of the structures and it is composed of alternated coral rock and limestone fragments consolidated with composite mixed mortar mixture. This layer was consolidated during the last intervention using mud and cement mortar.
