AN INVESTIGATION INTO CRANE AND SCAFFOLD SAFETY IN CONSTRUCTION INDUSTRY

The aim of this study is to determine whether construction sites involving cranes and scaffold in Australian large construction sites have been in compliance with the existing Work Health and Safety (WHS) requirements. The research comprises three case studies which investigated the causes of crane and scaffold safety incidents that occurred in New South Wales. The results of the case study on a number of separate sites in Sydney, NSW have shown that without stringent safety procedures in place to abide by the WHS Act and Regulations, major accidents can occur and can cause serious injury and could cause potential fatalities while working with cranes and scaffold. Results also found that a number of limiting factors including communication skill, regular maintenance, safety checks, safety culture and safety investments could contribute to the severity of the incidents.

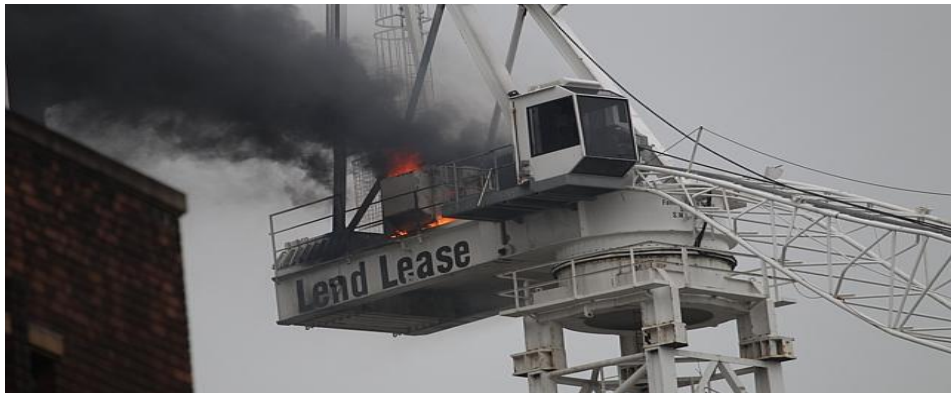
On 27th November 2012, news broke that a tower crane had caught on fire at the outskirts of the Sydney CBD at a construction site at the University of Technology, Sydney (UTS) (Figure 1). More than 100 workers and 100 bystanders were in surrounding buildings and were evacuated from the area. The crane operator managed to escape the cabin through the crane ladder. The boom of the crane ultimately collapsed and landed on the building structure below.

Figure 1. The tower crane at Ultimo construction site on fire.

A newspaper article reported that safety maintenance was not up to date and the company had failed to undertake regular safety check even though it was pointed out to them through an earlier safety inspection (Australian Financial Review 2012). After discussion with officers of the WorkCover Authority of NSW and a review of the incident report it was confirmed that the protruding arm of a crane had collapsed on top at the University of Technology, Sydney, construction site after catching fire.

After considering the news reports on these various incidents and then obtaining incident reports through WorkCover, it is evident that there was a breach of work, health and safety requirements on these construction sites. The first incident in Ultimo could have been fatal had the jib of the crane been pointing out towards the road where hundreds of commuters were passing. It seems that the regular safety and maintenance checks were not carried out on this site. Fuel leaks are reported to have initiated the fire which in turn then caused the crane to collapse. If the appropriate maintenance checks were in place then the incident could have been avoided. It was fortunate that there were no injuries or fatalities although the company in question would still likely receive a heavy fine for an incident of this scale.

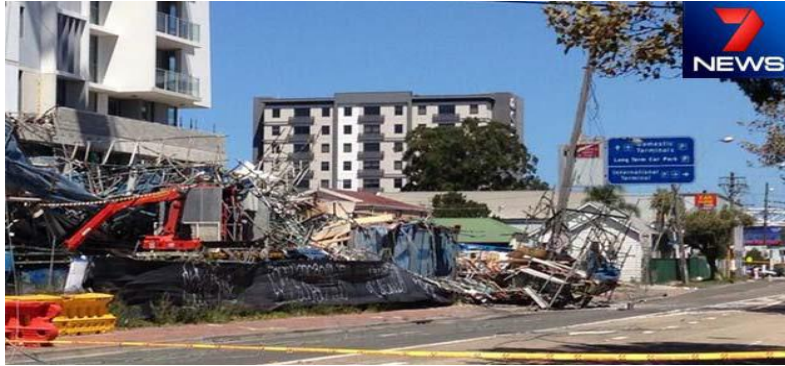
On February 25th, 2014, it was reported in the local media that a scaffolding structure had collapsed on a construction site in Mascot, New South Wales (Yahoo7 2014) (Figure 2). Two men were on a scaffold at the time of collapse and fortunately they escaped with only minor injury. It was also reported that the collapsed scaffold brought down power lines on the street and completely covered two trucks. There was also a concern for leaking fuel from the impacted trucks. As a result of the incident more than 100 people had to be evacuated from the area. The NSW Police and the WorkCover Authority started their investigations immediately after the collapse was reported. After discussion with WorkCover Authority officers and reviewing the information in the ‘Factual Inspection Reports’, it was found that the scaffold collapse was caused by:

- (i) A number of broken cables which were hanging from the services pole (electricity and telecommunication);

- (ii) Scaffold and building debris which were resting on the services pole;
- (iii) Scaffold and building debris protruded out from the building site onto a Street which blocked one lane of road for traffic;
- (iv) Parked trucks were covered with collapsed scaffold, raising concerns of fuel leaks; and
- (v) Damage to the exterior wall of the existing building next to the collapsed scaffolding. The workers' union also inspected the site a few months earlier and raised concerns about the safety of the scaffold.

Figure 2. The collapsed scaffold at the Mascot building site.

The Mascot incident suggests that regular checks of the scaffold were not undertaken and resulted in a collapse in which two workers were seriously injured and narrowly avoided death.

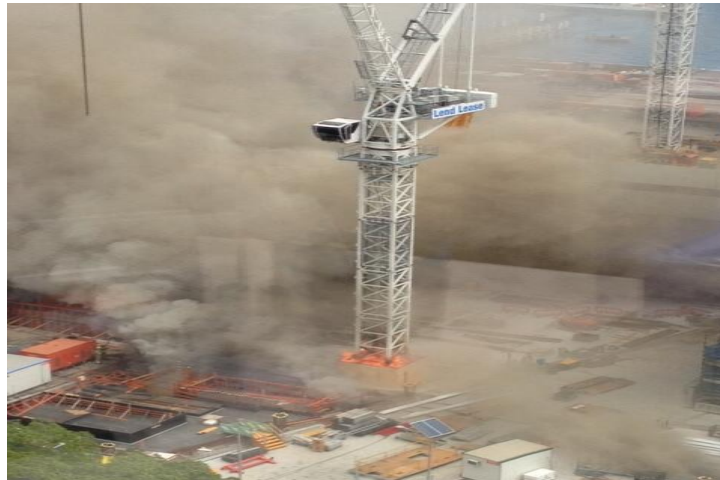
On 12th March 2014, a fire broke out in the basement of a building on the Barangaroo development project in Sydney's CBD (Figure 3). A large blaze resulted in dense smoke being omitted from the construction site raising the alarm to existing surrounding high-rise buildings. Residents from all surrounding buildings were evacuated as a safety precaution (Ralston and Patty 2014). Fire persisted for several hours until the fire was brought under control. There was also a concern that the fire could cause damage to the tower cranes substructure and result in a collapse of the crane. Main roads surrounding the construction site were closed off, causing traffic chaos during the afternoon peak hour commuting period. Fire fighters from NSW Fire and Rescue responded until the blaze was controlled. Fire fighters fought the fire over two days with substantial damage to onsite construction material. The crane did not collapse and after the fire was extinguished, engineers were brought in to assess the structural integrity of the crane. WorkCover mentioned in their report that the fire appears to have been caused by a welding accident which set fire to formwork (Ralston and Patty 2014). Approximately 40 to 60 workers were on the lower levels when the blaze broke out and narrowly escaped death or seriously injured (Ralston and Patty 2014). After discussion with WorkCover officers and review of the Incident Report, it was confirmed that the large fire originated in the formwork at the basement area. The incident report also confirmed that a structural engineer would assess the area and provide a remediation plan to be followed before construction would re-commence.

Figure 3. The crane incident at the Barangaroo development project near CBD.

The Barangaroo incident was quite an extraordinary case as the events that unfolded were not directly related to the crane. Although the matter is still being investigated and recently reported that a basement fire was lit in close proximity to the base of the crane and was likely to be the initiating event. It was expected that the crane would have collapsed under the heat of the blazing fire. An interview with the Project Manager and Site Manager identified that the design of crane should also consider fire safety.
