STRUCTURAL CONCEPTS IMPLEMENTED WHILE SURVEYING BUILDINGS OF HISTORICAL AND CULTURAL SIGNIFICANCE

MIROSLAV TODOROV and MIHAIL TODOROV

Structural Design Ltd, Sofia, Bulgaria

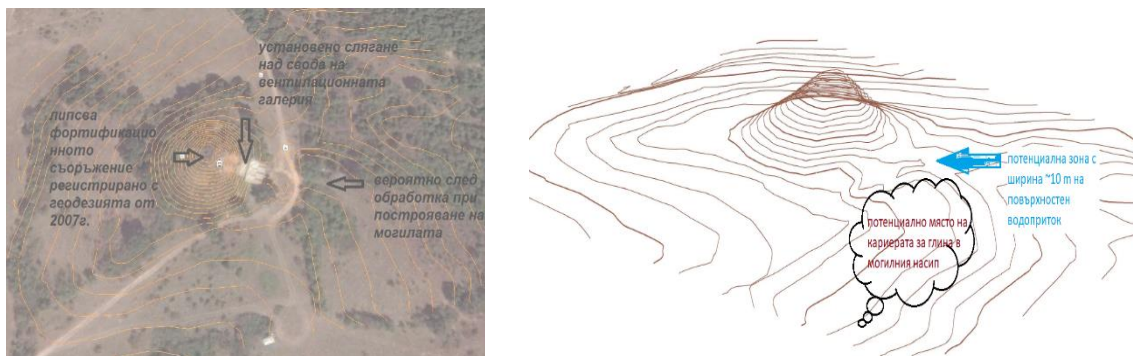
Figure 1. Situation and a model of the terrain of Roshavata Chuka.

The relief of the mound and the loading at the top, left from an old excavation for military purposes, in 2015, created conditions for the retention of atmospheric waters and the conduct trout water directly on the burial chamber, the Dromos and the newly built gallery. At the time of

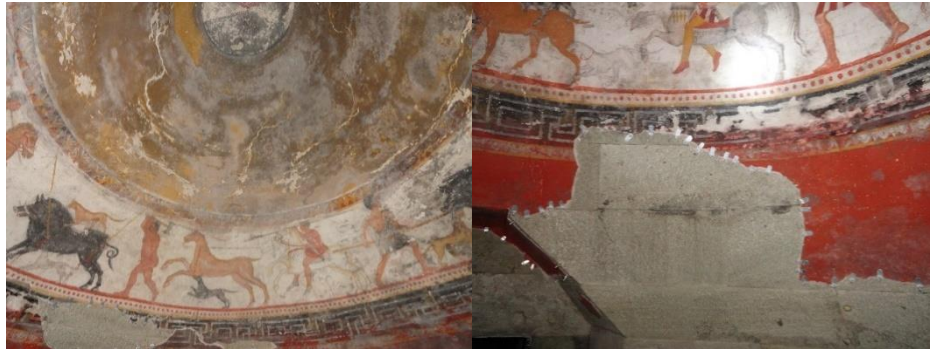
the examination in 2017 this form was retouched, and the topography of the tumulus resembles the conical shape, but the time has left its mark (Figure2).

Figure 2. Vault and entrance to the camera.

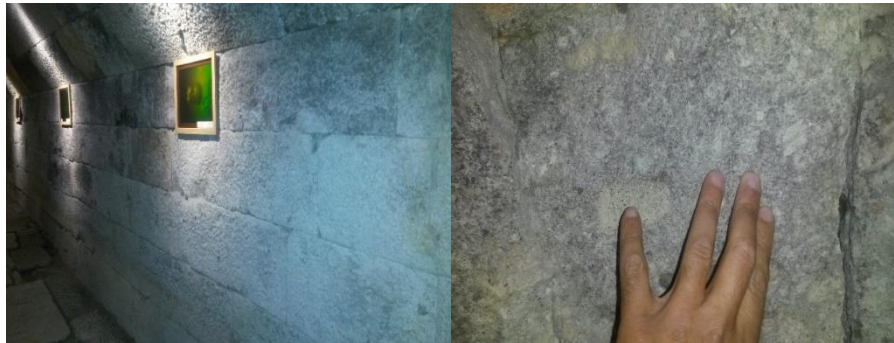
- Until now the tomb has preserved its structural stability and this fact is predetermined by the almost complete preservation of the mound;
- Traces of dilution of the structure at the inlet of the Dromos have been identified. The causes of these processes are the long-term horizontal deformability of the mound body and the human intervention when opening the inlet.
- The entrance of the Thracian beehive Tomb in its authentic form was shaped by a stone slab and the rest-blocked by stone blocks.

Figure 4. Dromos and interior view of Riolite Quadra in Dromos.

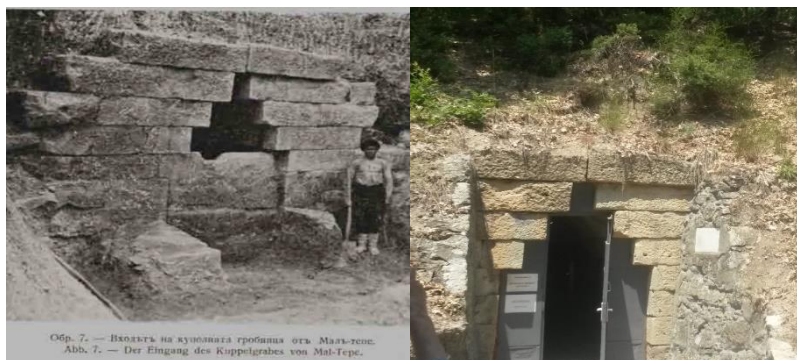
The current entrance does not reflect the original decision of the last period of use of the monument (Figure 5). This coincides with the B. Filov study of 1932, according to which a well-formed input structure existed at the entrance to the Dromos. It has performed a counterforce function in relation to the construction of the Dromos and with its dropping horizontal strain in the masonry has developed. The movement is also stimulated after opening the tomb and removing the mound body. After this period, erosion was developed, which in recent decades has declined from the self-forested surface of the mound (unlike the Naked Mound in 1931).

Figure 5. Entrance to the Dromois – left (b. Filov-Notices of the Bulgarian Archaeological Institute volume XI from 1937 years), right-2017.

the mound would lead to a number of negative consequences related to the redistribution of the forces in the masonry and the slippage in the contact between the individual frames and vaulted blocks. Our findings focused on the use of techniques for minimal and delicate intervention for conservation by storing the burial structure in its authentic visage – together with the mound.
