# **AN EXHAUSTIVE SURVEY FOR RENOVATING FACILITIES IN DENSELY BUILT-UP WOODEN HOUSE AREAS**

*Division of Architecture and Urban Studies, Tokyo Metropolitan Univ., Tokyo, Japan*

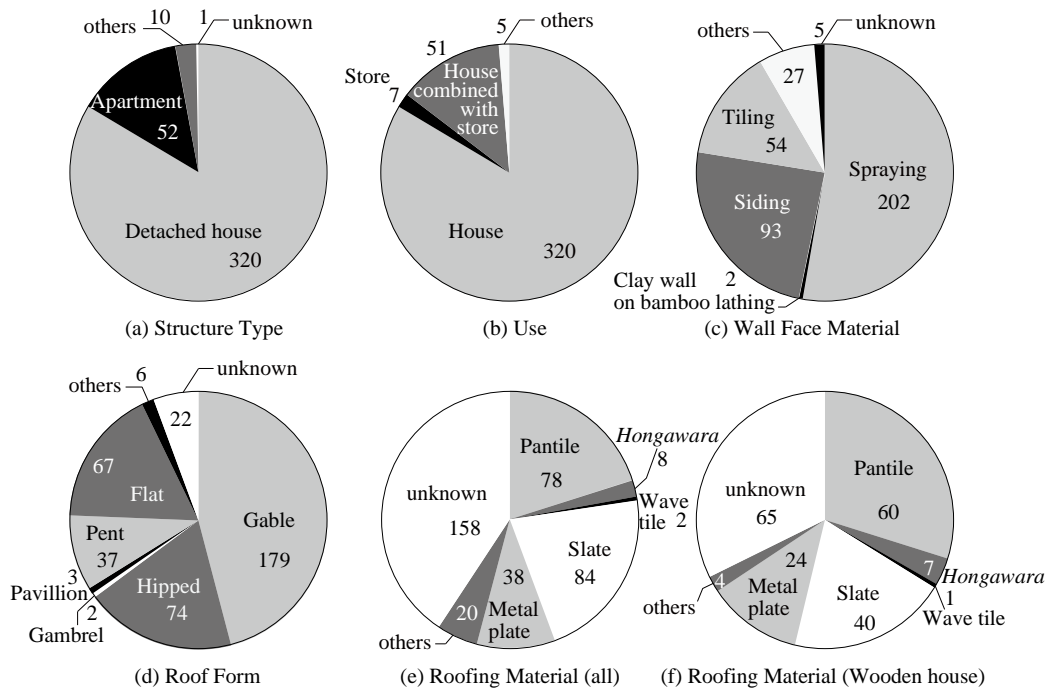
Figure 2. Statistical data for structures.

We classified the statistical data for the structures as shown in Figure 2. Of the buildings, over 80% were detached houses (see Figure 2(a)); 320 were used as houses, and 51 were used as both a house and a store (see Figure 2(b)). There were six vacant houses (Figure 3(a) shows an example; it is covered with ivy).

The wall-face material of over half the building was splaying, and that of approximately a quarter of the building was siding (see Figure 2(c)). There were 16 billboard architectures, i.e., wooden houses with a mortar wall only in the front (see Figure 3(a) for an example). As shown in Figure 5(a), buildings with various structure classifications are interspersed.

Nearly half of the buildings had gable roof; others had a hipped, flat, or pent roof (see Figure 2(d)). Slate and pantile were observed in the roofing material for all buildings, and in case of only wooden houses, it is the almost same ratio (see Figures 2(e) and (f)).

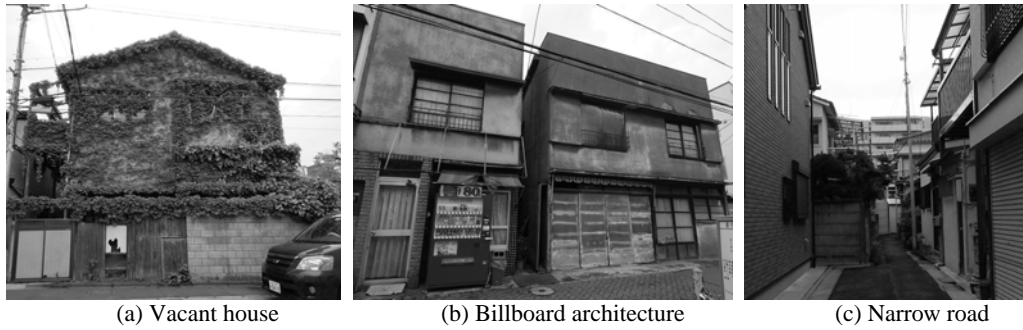
Figure 3. Statistical data for structures.

The distances between adjacent buildings were extremely small. Regarding the width of the frontal road, we found that 79 buildings adjoined the road with a separation of 2 m or less (see Figure 3(c) for an example).

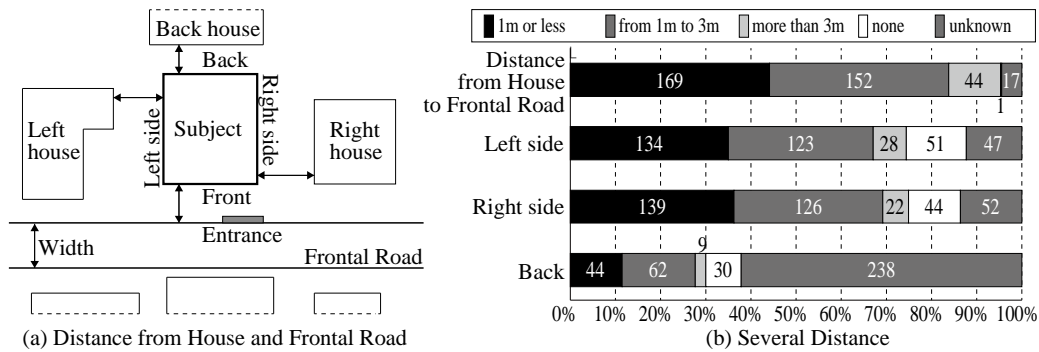
Figure 4. Measured distance around house.

The distances to all quarters of the house were defined as shown in Figure 4(a), and

the measurement results are shown in Figure 4(b). Nearly half of the buildings are located 1 m or less from the frontal road. The contour of the distance from the frontal road is shown in Figure 5(b). In the area divided into geographic sections, we found that the buildings were densely packed.
