REHABILITATION OF BOX GIRDER BRIDGE

A large pre-stress continuous box girder bridge consists of two separate parts, ten spans deck and eight spans deck. The bridge was subjected to multiple airstrikes, which caused several damages. The most serious are the complete destruction of four conductive spans in the ten spans deck, the movement of the remaining six spans longitudinally by about 1.25 m and transversely by about 0.1 m. Local damages occurred in other parts of the deck structure and minor damages in the piers and abutments. The deck structures were constructed by incremental launching method (ILM). Rehabilitation of the bridge included repair of the local damages, lifting and reinstatement the six spans, which weighs about 9,000 tons, to its original position, the constructing and launching of new box girder to substitute for missing spans, and finally connecting old and new spans effectively. This paper introduces briefly the reinstatement of the six spans, connection details between the old new structures, then assessing the efficiency of connection by analysis and load testing the connecting span.

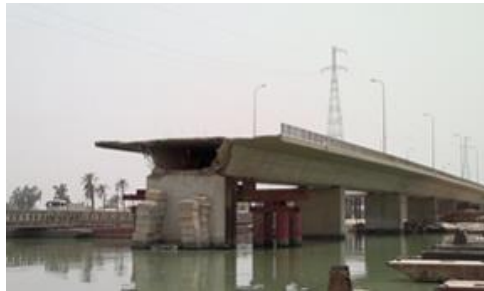
Figure 1. Plan of the bridge.

Al Fayha'a bridge connects east and west banks of Shat Al-Arab river at Al Basrah city in Iraq. Its super structure consists of two structures separated by expansion joint at pier P(2-1). Each structure is continuous single cell pre-stressed box girder. The outside dimensions of the box are 7 m wide at the bottom, 10.4 m wide the top, and 3.55 m total height (AlKhazen 1974). The east part is ten span with total length of 430.15 m as shown in Figure 1. While the west part is eight span with total length of 330.75 m. It was constructed in the mid-seventies of the last century using incremental launching method (ILM). The bridge was built by the German company Polansky and Zolner using their post tensioning (PT) system, which consists of bonded cables made of 40 mm² oval wires grade ST 1420/1570 (Polensky & Zöllner 1969). The longitudinal PT are PZ A100 (33 wires) with effective force of 1,180 kN. While the transverse PT are PZ A40 (12 wires) with effective force of 393 kN. The concrete used is "Beton 35" with 28 days cylinder compressive strength of 35 MPa. The number of longitudinal cables are 26 in the top flange and 10 in the bottom flange for the bridge length.

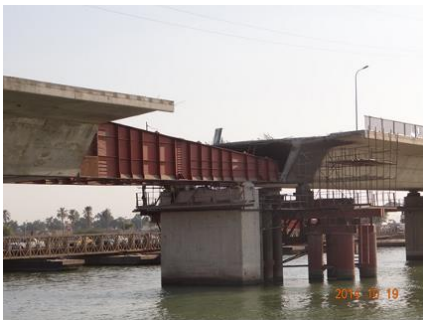
Figure 3. New spans and launching nose.

- To construct the four new spans, (ILM) starting from east abutment is used. Double steel plate girder launching nose about 30.72 m is connected to the face of first increment using 50 mm diameter pre-stressing bars grade 1,030 MPa. Figures 3 and 4 shows the new spans during launching.

- Concrete with 28 days' cylinder compressive strength of 40 MPa is used.
- Freyssinet system C&B strand cables TISS with steel grade S1640/1860 are used.
- Internal prestressing made of bonded strands in steel strip sheath.
- External pre-stressing made of individually greased and sheathed strands in external duct which is injected with cement before tensioning.
- Re-Charge of existing PT cables.
- Top pre-stressing tendons at pier P(2-7) used are 8-19T15S with total area of (22,800 mm²), while at piers P(2-8) and P(2-9), 12-(19T15S) are used.
- The first increment is projected into span (6) by about 3.62 m, and away from clear cut end of old structure by about 2 m; cast in situ segment is used to connect two structures.

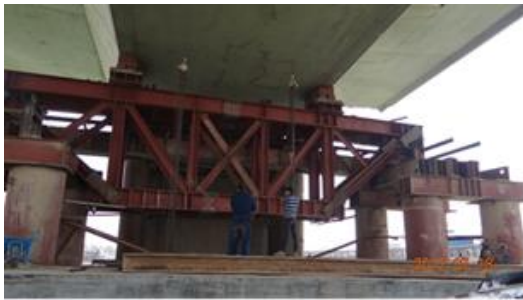
Figure 5. Reinstating original structure.

Two pairs of 500 ton capacity hydraulic jacks as shown in Figures 5 and 6 were provided at piers P(2-2) to P(2-6) and on one pair at temporary supports near P(2-1) and P(2-7), for vertical lifting. These jacks are supported on secondary steel chairs, which in turn supported on main steel chairs with very low friction pad separating the two chairs. Flat jacks were installed between the two chairs to cause transverse movement of the deck, after transferring the load of the six spans to the vertical jacks. After correcting the alignment of the six spans, the spans were lifted to their design level. Then the old bearings were replaced by new ones, which were designed to allow longitudinal sliding. The longitudinal movement of the six spans was achieved by using prestressing jacks for which special steel structures designed to be fixed to the two stiff diaphragms of the east and west bridges. The jacks' reaction was on the west diaphragm and the pull force acted on the east diaphragm, moving the six spans westward until their final location.

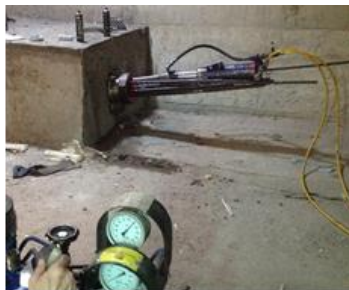
Figure 7. Anchoring old tendons.

Although span six did not show signs that the pre-stressing tendons loosing bond with the surrounding concrete of the box section, special steel anchors (shown in Figure 7) were used to anchor the ends of the tendons near P(2-7). The connection of the two structures is as follows (Freyssinet 2015):

- The 2 m long segment casted between the two structures. Two blisters were casted with the bottom slab, to anchor one end of two 19T15S bottom tendons, where the other ends were anchored at newly constructed blisters against the diaphragm at P(2-6).

- A special reaction frame was casted 10.82 m from P(2-7) inside the old structure against two already existing blisters on the webs of the old structure. This was used to anchor four prestressing bars near top of the box girder, then two rows of 4-19T15S tendons, one near each web. Each bar was stressed to about 1,500 kN, each of the upper two tendons was stressed to 3,700 kN, while each of the lower two tendons was stressed to 2,650 kN. The other ends of the bars and tendons were anchored at the diaphragm at P(2-7).
