# ANALYSIS OF BUCKLING AND BENDING FAILURE OF ALUMINIUM COLUMN SECTIONS USED IN EMERGENCY RESTORATION TOWERS

This paper presents an experimental analysis of buckling and bending failure modes of a 2.58 m long, 460×460 mm<sup>2</sup> 6061-T6 Aluminum alloy column section used in emergency restoration towers. The main objective is to determine the bending and buckling load capacities of the column section through experiments, as these values are critical in an emergency tower (guyed mast) design. Within the context of this overarching goal, a secondary objective is to ascertain whether the presence of certain manufacturing non-conformance affects the loading capacity of the section significantly. Finally, finite-element analysis (FEA) simulations are conducted in order to compare the experimental data with numerical results. The results show that the ultimate bending and buckling load capacities of the column section are 383 kN and 3,868 kN respectively. Furthermore, the results indicate that the presence of manufacturing non-conformances such as air bubbles and delamination do not have a detrimental effect on the load capacity of the column. Of the two non-conformances studied, the

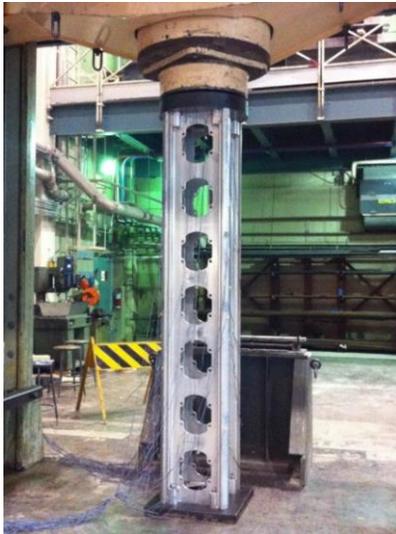
For the buckling test shown in Figure 1, the load is applied on the top along the vertical axis of the tower modular section specimen via a pivoting head connection. A 600×600×50 mm<sup>3</sup> steel plate is fixed to the bottom of the modular tower section by 8 ASTM A324 bolts in order to fix the end of the column on the ground. The bending test was conducted by setting the specimen on two roller supports 100 mm distance away from the ends, as shown in Figure 2. The bending load is applied at the middle of the modular section via a pivoting head connection and a steel plate.

Figure 1. Buckling test experimental setup.

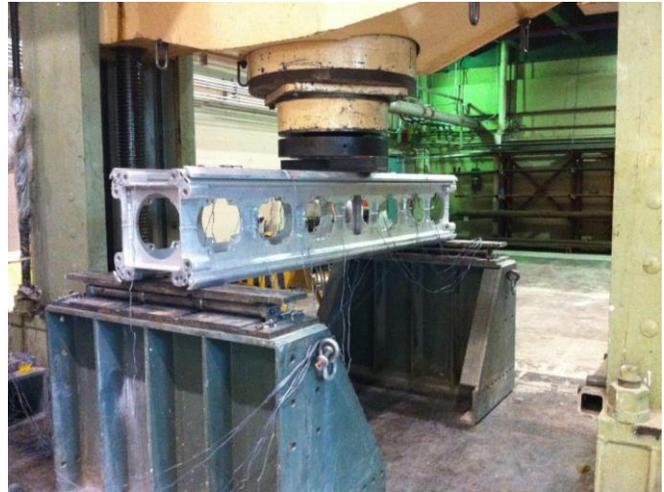
Figure 2. Bending test experimental setup.

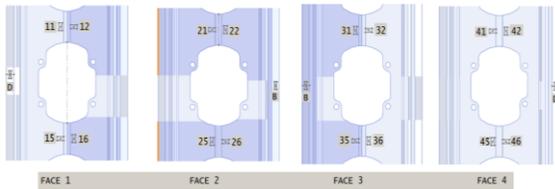
Figure 3. Strain gauge locations for bending tests.

Local strain and stress were determined using strain gauges. These gauges were positioned at areas predetermined to be critical from an initial FEA simulation. Based on the results of these tests, the number of strain gauges was adjusted for the subsequent tests. The gauges were also subsequently concentrated on areas where failure was determined to occur from the initial experimental tests, particularly on the heat affected zones (HAZ) of the aluminum welds. Figure 3 and 4 show the location of strain gauges for the bending and buckling tests, respectively.

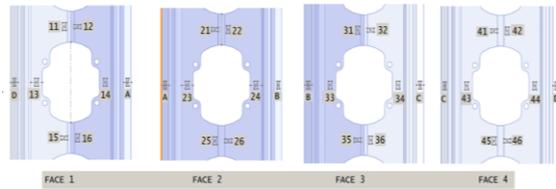
Figure 4. Strain gauge locations for buckling tests.

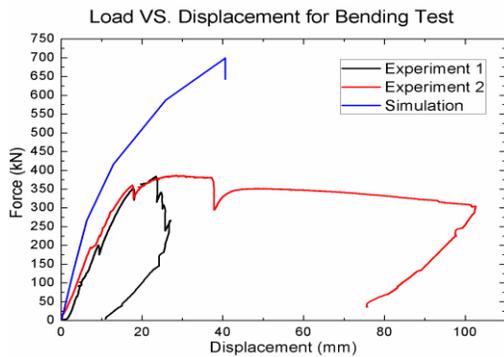
Two bending tests were conducted, and the results were compared with the FEA simulations. The maximum loads reached before failure for first (rejected) and second (good specimen) experimental tests before failure were 383 kN and 386 kN, respectively, as shown in Figure 5. In the corresponding FEA simulation, the maximum load reached before failure was almost two times greater than the experimental values, and the initial stiffness was marginally higher in the

FEA. Comparisons between the experimental results of the two specimens showed that the maximum displacements for the rejected specimen were 23.5 mm and for the good specimen was 28.5 mm. Comparing failure modes, the reject specimen had six ‘drop’ points, each of which indicates cracking in the aluminum welds. As the load increased over the load bearing capacity of the welds, they cracked, causing the applied load to decrease. This is evidenced by the drop in the load-displacement curves. For the test of the ‘good’ specimen, only two of the welds fail, implying that the aluminum section had carried a greater load beyond the ultimate tensile strength of the material. Figure 6 shows the two specimens at the completion of the tests, and Table 2 provides the stress values as determined by the strain gauges. It is observed that the values are mostly below the yield stress of 275 MPa.

Figure 5. Load-displacement curves for the bending tests.

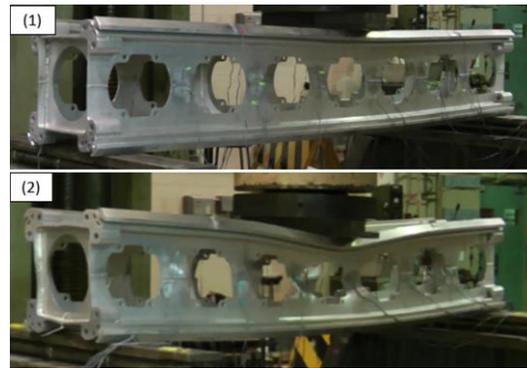
Figure 6. The specimens at the completion of bending test 1 and 2.

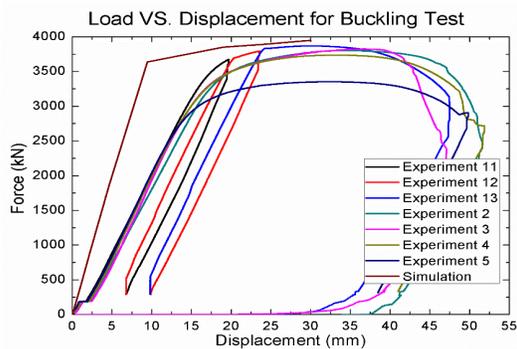
As mentioned earlier, five specimens were used for the buckling tests, and the loads applied before failures are listed in Table 1. The load-displacement curves for these five specimens are shown in Figure 7. The displacements ranged from 30 mm to 38 mm, and the initial stiffness for

each test is almost the same. The FEA simulation shown in Figure 8 indicated a higher initial stiffness, but the same maximum load, as shown in Figure 7. As mentioned before, the first two buckling tests used the maximum number of strain gauges, which were strategically positioned near the welds between each hole. Figure 4 shows the initial location of the strain gauges, and Table 3 shows the corresponding stress values. Stress values obtained for locations 11, 12, 21, and 22 are omitted from the table since the measured stress is not critical at those locations. It can be seen that most values measured by the strain gauges are in the elastic range, and only a few are beyond the yield strength. It is further observed that the strain gauges showing readings in the plastic range are predominantly in the corners of the specimen.

Figure 7. Load-displacement curves for the buckling tests.

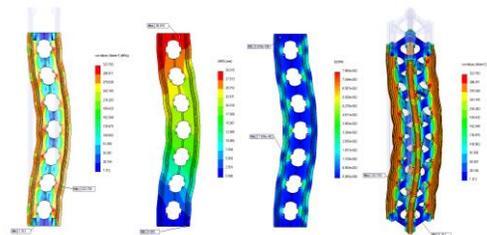
Figure 8. FEA simulation results for the buckling test.

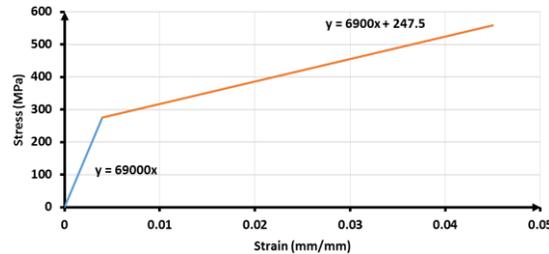
Using load-displacement curves discussed above and the local strain measurements from the strain gauges obtained during the experiment, the strain values can be translated into stresses given the stress-strain relationship of the aluminum alloy. The elastic modulus is 69,000 MPa; the yield strength is 275 MPa, and the ultimate tensile strength is 310 MPa. A simplified stress-strain relationship was also obtained from an FEA analysis and is shown in Figure 9. The local stresses are obtained from this curve.

Figure 9. Simplified stress-strain curve for the aluminum alloy.
