# THE MYTH OF SAW-CUT JOINTS IN CONCRETE SLABS AND WALLS

MUANGSANGOP SENIWONGSE

This paper is concerned with the world-wide practice of providing shallow saw-cut joints or v-grooves at regular spacing, for structural purposes, in concrete walkway slabs, slabs-on-grade, and parapet walls. The primary purpose of this paper is to raise awareness among engineers that the practice is a myth and has no structural advantages, and for the engineers to *think* of a better and more positive/reliable approach to concrete crack control. The other purpose is to make aware the need for engineers to think and observe actual behavior of existing structures, and use that observation to improve future design, and not repeat unsound or useless practices. Elimination of useless saw-cut joints in future construction would save the whole world billions of dollars. The author demonstrates that the saw cuts have no structural impact by showing the pictures taken in New York of typical cracks seen on walkway slabs and parapet walls, and on garage floor slabs that were built with saw-cut joints. Note that this type of actual field observation is more representative than the crack observation on small conc

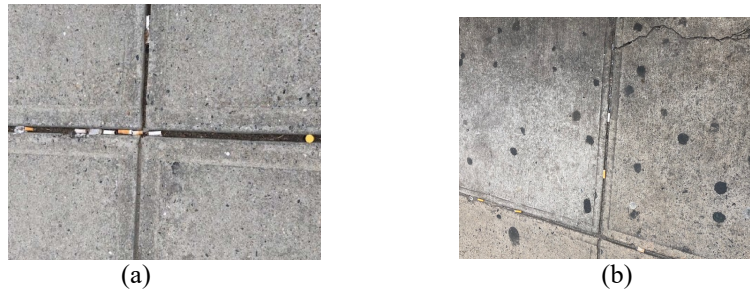
Figure 3 (a), (b). Cigarette ends trapped in saw-cut grooves in walkway slabs.

It will be evident in Section 3 that saw-cut joints have no structural advantages on the behavior and performance of the slabs or walls. The only effect - they are seen to be effective in trapping of dirt and cigarette ends on the walkways as shown typically in Figure 3.

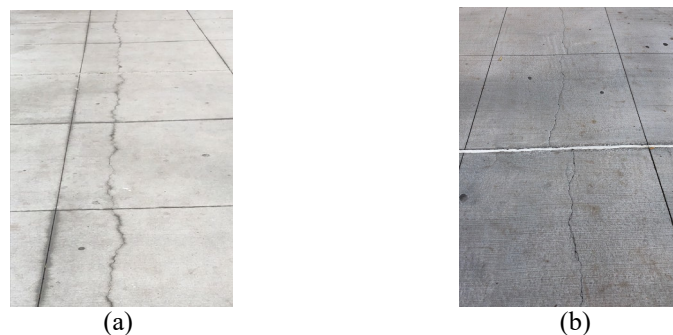
Figure 4 (a), (b). Cracks in sidewalk concrete slabs on Park Ave. in New York City.

This Section shows typical concrete cracks commonly seen in concrete slabs and walls that incorporated saw cuts. All pictures were taken in 2018. Figure 4 shows concrete cracks in the sidewalk slabs. Figure 5 shows concrete cracks in the slab-on-grade parking garage floor in a six-month old apartment building in New York. Figure 6 shows cracks in concrete parapet wall of a bridge with v-grooves at about five to six feet spacing. The cracks are seen in this case at about one foot away from the groove joints.

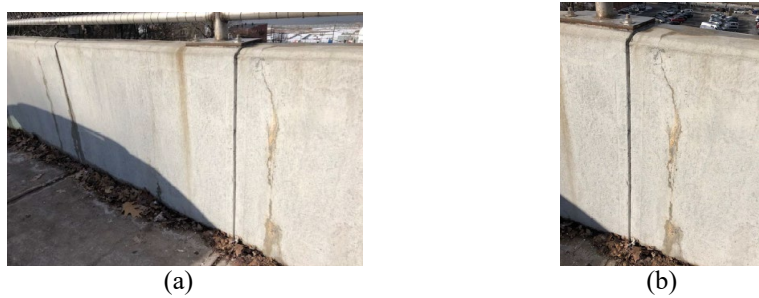
Figure 6 (a), (b). Cracks in NY bridge parapet walls with saw-cut joints.

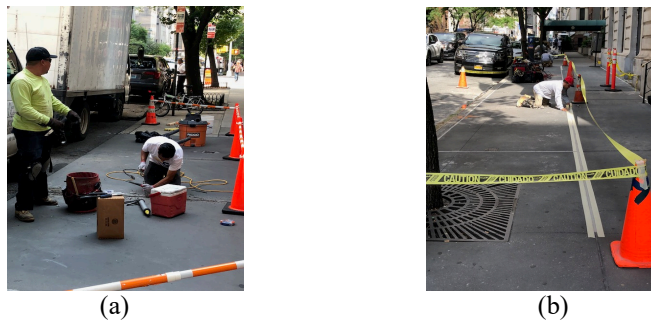
Figure 7. (a) Saw cutting grooves in walkway slab, (b) Taping saw-cut groove before applying sealant.

All joints require maintenance and repair, sooner or later. All pictures of repairing in this Section were taken on Park Avenue in New York in 2018. Figure 7 shows maintenance work on the grooves. Figure 8 shows the demolition of extensively cracked walkway and recast of new slabs.

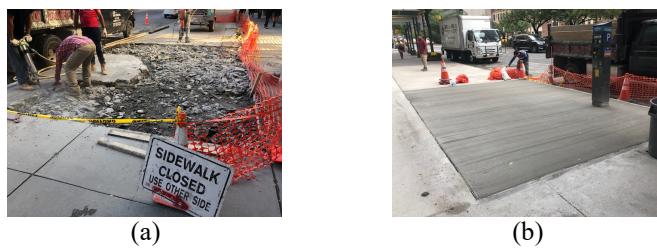
Figure 8. (a) Removal of cracked walkway slab, (b) Recast walkway slab.

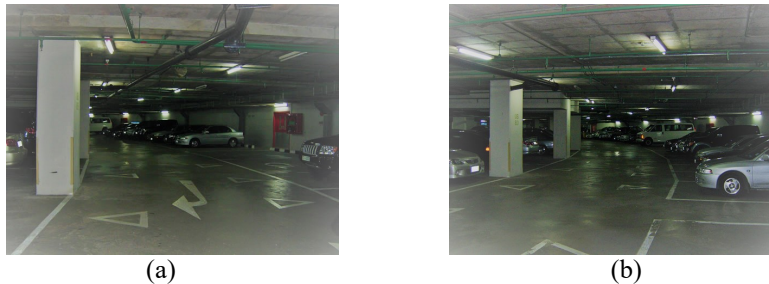
Figure 9. Crack-free garage basement floor in UN-ESCAP Conference Building (Seniwongse 1991).

This Section shows examples of concrete garage floors and bridge parapet walls which have been in service since 1990s and are still in excellent conditions without any cracks. The concrete slabs and walls were designed and built conventionally without any saw cuts. The pictures in Figures 9 and 10 were taken in 2008, after some 15-20 years after the completion of construction of both projects. Figure 9 shows the underground bottommost basement garage floor of the United Nations' Conference Building in Bangkok, built in the early 1990s (Seniwongse 1991). Figure 10 shows the pictures of the parapet walls of 40-km long expressway bridges in Bangkok that was built around 1988-1991 (Seniwongse 1989). The deck itself is continuous using innovative link slabs between spans (see Jointless Bridge (Seniwongse 1990)).

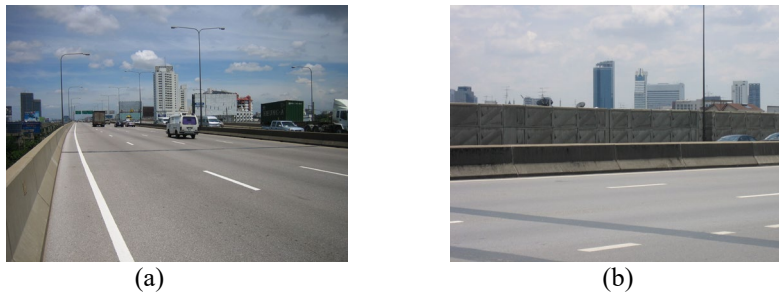
Figure 10. Crack-free parapet walls on 40-Km viaduct in Bangkok (Seniwongse 1989).
