VIBRATION PROPERTIES OF TRADITIONAL MASONRY WALLS OF CORTES CHURCH

The Santo Niño Church in Bohol Island was partially damaged in the Bohol Earthquake in October 2013. In this study, we investigated the structural property of the Santo Niño Church to understand the vibration characteristics of Philippine masonry constructions by checking the main damage and conducting measurement surveys and microtremor measurement on the structure and ground. The major findings of this study can be summarized as follows: (a) Collapsed walls, peeling wall stone, corner deformation, and collapsed ceiling were the main damages that were observed. The collapsed wall was measured, and the make-up and material thickness of the wall was verified. (b) By performing microtremor measurements on the walls, the vibration property of the church, such as the natural frequency and vibration mode of the longest wall A was clarified. The 1st natural frequency of the longest wall A is the lowest.

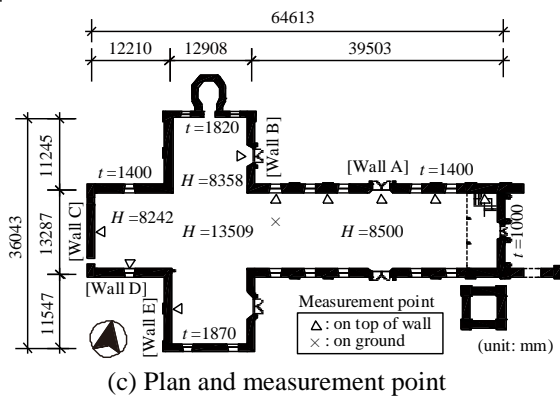
(c) Plan and measurement point

as shown in Figure 2 (c) and Table 1. Then, estimated values of the nearest wall, as shown in ‘()’, were used as thickness value for walls whose thickness could not be measured.

We conducted microtremor measurements on the walls to clarify the vibration property of the church. The measurement was performed at several points on the top of walls, A–E, as shown in Figure 6. In Figure 2 (c), the measurement points are marked by triangles. The simultaneous measurement was conducted at multiple points by installing one velocity sensor on the ground and some sensors on the wall. Five sensors were installed at wall A to understand the vibration mode. Then, the Fourier spectral ratio is defined as the Fourier spectra on the wall divided by on
