ANALYSIS OF HAGIA SOPHIA USING NONDESTRUCTIVE MESUREMENT

TAKASHI HARA¹ and KENICHIRO HIDAKA²

In this paper, the structural behavior of Hagia Sophia was analyzed by use of vibration records of the structure. The vibration records were measured by the micro tremor meters. The recorded data was utilized not only to define the mode shape but also to evaluate the structural problems. Firstly, the vibration characteristics of the main building were analyzed by combining the vibration records. Secondary, the deformation characteristics and the structural functions of the second cornice were investigated in the same manner as the main building. In case of main building, from the frequency domain analyses, the natural frequency of the main building was analyzed and the obtained natural frequencies were compared with the results of the previous researches. The vibration modes were investigated as well. From these results, the characteristics of the total structure were clarified and the structural problems were detected. In case of the second cornice, the base at the corner where was the junction of the main pier and the sub-dome connecting to the semi-dome showed the movement of the embed

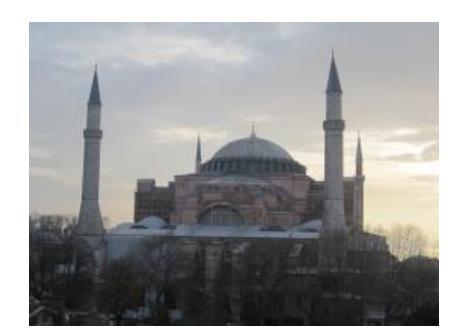
Figure 1. Hagia Sophia.

The building has been attacked by the strong earthquake in several times and by the penetration of the water and moisture. Therefore, several problems, such as cracking of the walls and the domes, inclination of the columns and water penetration, are detected.

In addition, due to the different depth of the bed rocks and the large deformation of the materials, the building structure shows a lot of damages on the surfaces and represents the incredible structural deformation. To restore and to conserve such a huge heritage structure, the detail structural inspections are required.
