BASAL STUDY ON SIMPLE THICKNESS EVALUATION FOR ROAD-LIGHTING POLES WITH LOCAL CORROSION NEAR THE BASEPLATE

TOMOHIRO MITSUNAGA¹, TATSUMASA KAITA¹, and KATASHI FUJII²

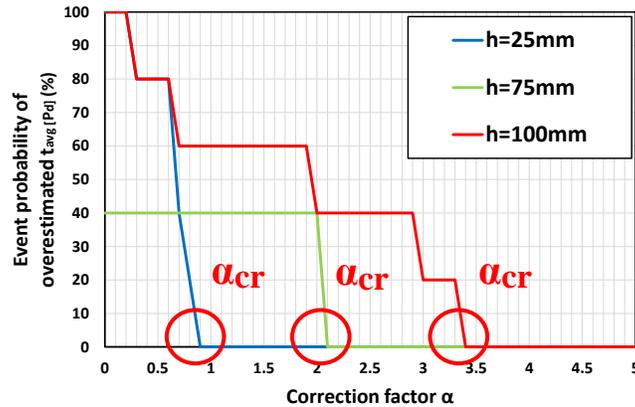
Figure 4. Event probability of overestimated P_d .

Figure 4 shows the relationship between the event probabilities of overestimated average thickness P_d and the thickness correction factor α . Event probabilities P_d can be calculated by counting the number of overestimated cases in all combinations of measuring unit, as shown in Figure 5.

These overestimated cases mean the modified average thickness t_m , which was obtained from Equation (1), was greater than the actual average thickness (obtained from 3D scanner). Correction factor α was changed numerically at the intervals of 0.1, after counting the number of overestimated cases. From Figure 4, it will be found that the event probabilities P_d will decrease with an increase in correction factor α . From this calculation, the critical correction factors α_{cr} when P_d reached 0% were decided in the case of $h = 25\text{ mm}, 75\text{ mm}, 100\text{ mm}$. Figure 6 shows the relationship between α_{cr} and σ_t . In this figure, σ_t was obtained from 20 measuring points cross-section at $h = 25$

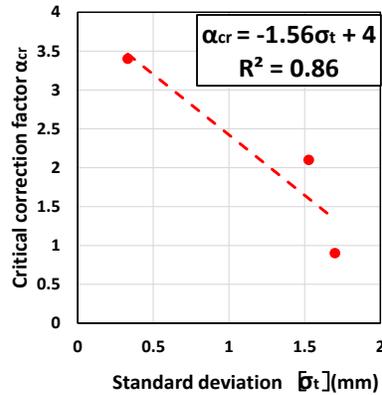
Figure 6. α_{cr} - σ_t relationship.

mm, 75 mm, 100 mm, respectively. If the correction factor α was decided from relationship such as Figure 6 by using the measurement result of only four measuring points, the average thickness will be modified easily from Equation (1) toward the safe side with consideration of the roughness condition (σ_t) of corroded surface. However, it should be noted that the α_{cr} - σ_t relationship will require the investigation for more cases of other corroded road-lighting poles in order to enhance reliability and generality.
