CORROSION BEHAVIOR OF FRICTION PLATE SURFACES CONNECTED BY HIGH-STRENGTH BOLTS

The aim of this study is to examine the corrosion behavior of friction plate surfaces connected by high-strength bolts under severely corrosive environments in steel bridge structures. The corrosion behavior was inspected using corroded specimens cut from a steel girder bridge that collapsed after severe corrosion for 28 years. Visual inspection and measurement of the corrosion thicknesses of the inner surfaces were performed. The arithmetic average roughness was also measured to evaluate the friction coefficient. From these investigations, it may be clear that the aging deterioration of the friction surfaces of joint plates connected by high-strength bolts is has little influence over the slip strength. The details of conducting investigations and their results are presented in this paper.

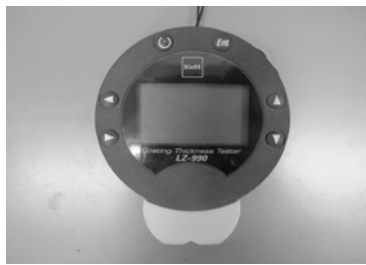
Figure 7. Electromagnetic thickness gage.

Corrosion thicknesses were measured at every 10mm on the inner surfaces of the fastener plate with an electromagnetic thickness gage, as shown in Fig. 7. The thickness of corrosion shown is the average value of the triple measurements. The corrosion thicknesses of inner surfaces of the fastener plate are shown in Fig. 8. From this figure, it can be seen that the edges of the inner surfaces are more rusted than the
