# **ANALYSIS OF DETERIORATION IN REINFORCED CONCRETE BRIDGE GIRDERS DAMAGED BY CHLORIDE DETERIORATION AND FATIGUE**

H. HONDA, T. SHIMOZATO, and Y. ARIZUMI

*Dept of Engineering, Ryukyu University, Okinawa, Japan*

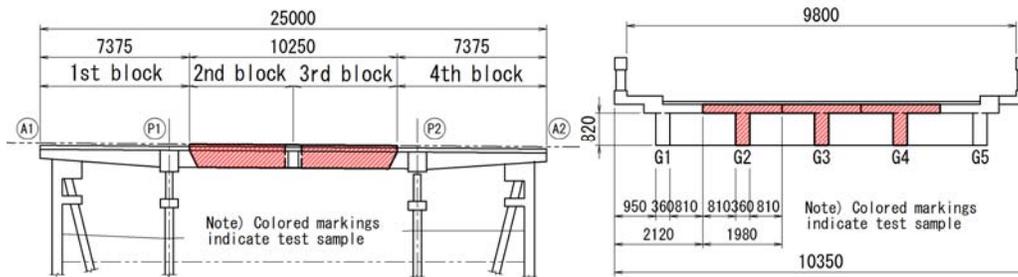
Figure 1 is a structural summary of the removed bridge. The bridge was 25.0 m long, with five main girders and sidewalks on both sides. The steel used was deformed reinforcing bar, and the design standard strength of the concrete, judging by the period of construction, is thought to have been 21 N/mm<sup>2</sup>. The bridge remained in use as a bridge for the old road, after a new bridge was built in 1987 to carry a bypass. In 2001, an investigation and tests, including external visual inspection and compression strength tests, were conducted to find the state of chloride-induced deterioration. Since that time, there have been reports of severe damage to the bridge, including reinforcing bar corrosion, and concrete scaling and spalling. The bridge was taken out of service from that time, and the decision was taken in 2011 to remove it.

Figure 1. Structural summary of the removed bridge.

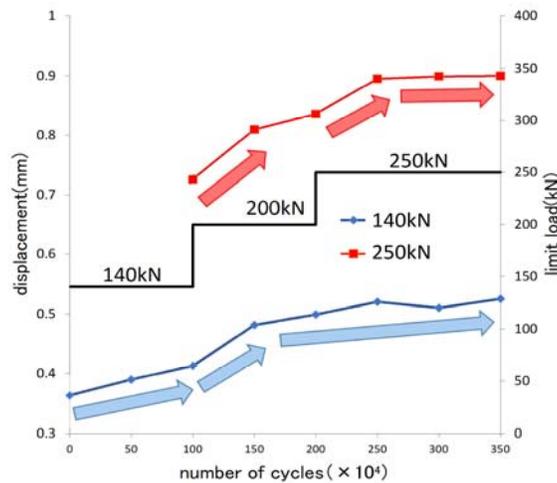
Figure 5 shows the relationship between displacement and loading number of times. As Figure 5 clearly shows, displacement is increased due to an increase in fatigue loading times and when fatigue loading limit load is increased from 140 kN to 200 kN, displacement of the static loading test was greatly increased. However, when fatigue loading limit load is increased from 200kN to 250 kN, only displacement of 250 kN has increased significantly.

Figure 5. Displacement - number of cycles relationships.
