# INVESTIGATION OF DAMAGE ON DERBENDIKHAN DAM DURING EARTHQUAKE EXCITATION

CAGRI MOLLAMAHMUTOGLU<sup>1</sup> and IDRIS BEDIRHANOGLU<sup>2</sup>

In this study, the performance of a damaged dam was evaluated through a three-dimensional finite element model. The dam is located in Derbendikhan city of Northern Iraq and damaged during a 7.3 magnitude earthquake which was happened 30 kilometers south of Halabja city. Derbendikhan dam which was built between the years 1956-1961 is a clay-core rock fill dam. The damage of the dam was investigated at the site right after the earthquake and some cracks were observed in the main body of the dam. The main goal of this work is to present the results of the survey which was conducted at the site and investigating the damage development mechanism through a realistic three-dimensional finite element model of the dam. As complying with the observations at the site, the finite element analysis has shown that the primary failure mechanism is due to the separation of the core and rock fill sections at the downstream side of the dam.

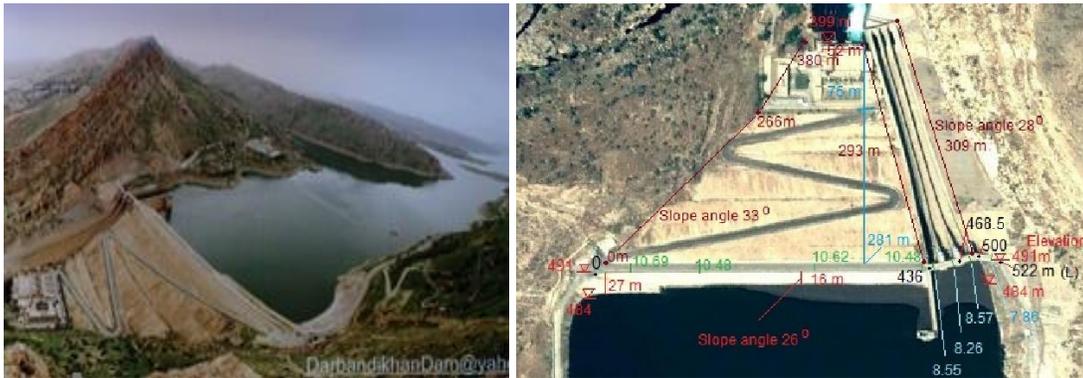
Figure 1. Close-up view of Derbendikhan Dam view from right bank and geometrical dimensions.

Derbendikhan (Derbendixan) dam is located inside a narrow valley near Derbendikhan district along north-northeast direction (Figure 1). Derbendikhan district in turn is located at the near south of Suleymaniyah province. The 535 m long dam is constructed on a thick limestone layer which is split off deeply by the streams feeding the reservoir and which sits on an alternate formation of mudstone and silt stone. It was constructed between the years 1956-1961 as a rock fill dam with a clay impermeable core. It has a height of 128 m and has a reservoir capacity of 3 billion m<sup>3</sup> (Figure 1). Lack of information required to obtain data from open sources and as a result geometrical data were measured from Google Earth as seen in Figure 1 left side. The exact dimensions of the clay core are unknown and assumptions made on the slope and bottom width of the core sections.
