PRACTICAL SEISMIC STRENGTHENING OF R/C BEAM-COLUMN JOINTS WITHOUT LATERAL REINFORCEMENTS IN DEVELOPING COUNTRIES

YASUSHI SANADA and YUEBING LI

Graduate School of Engineering, Osaka University, Suita, Japan

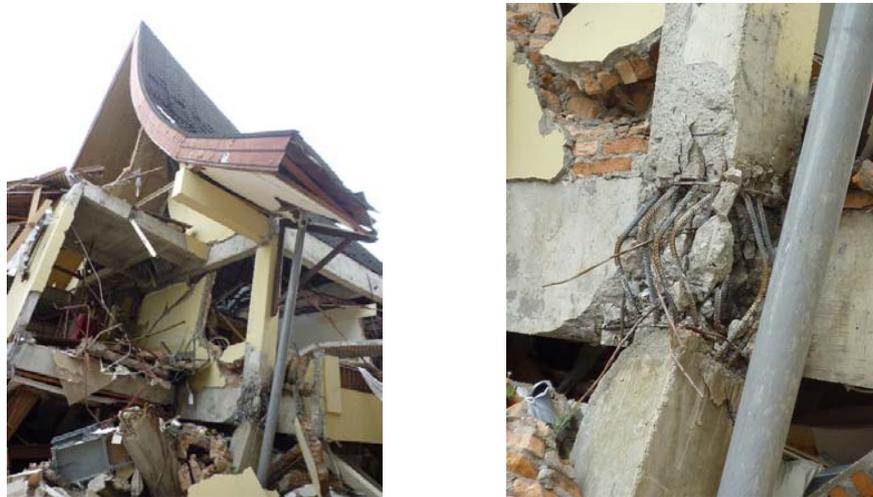
(a) Collapsed building

(b) Corner beam-column joint

Figure 1. Collapsed building and one of damaged beam-column joints.

A three-story R/C building is focused upon in this study, which totally collapsed in the first story due to the 2009 West Sumatra earthquake (Sanada et al. 2011). Figure 1 shows the overall building and a damaged beam-column joint at the corner on the third floor. No lateral reinforcements and insufficient anchorage of longitudinal rebars are observed in the figure. These poor structural details caused the building to collapse. Figure 2 illustrates the structural details of the joint observed during the field investigation.
