VERIFICATION OF REPAIR PAINTING EFFECT OF CORRODED WEATHERING STEEL BY EXPOSURE TEST

YUKA SUGIYAMA¹, TOSHIHIKO ASO¹, ATSUMI IMAI², and HIROAKI MATSUMOTO²

¹*Dept of Civil and Environmental Engineering, Yamaguchi University, Ube, Japan*

²*Nippon Steel Anti-Corrosion Co., Ltd, Kimitsu, Japan*

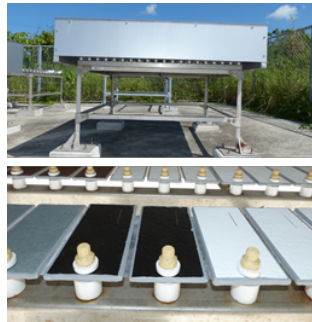
Figure 1. Exposure test at Okinawa.

Corroded weathering steel was required to consider the repair method of corroded weathering steel. In this study, 3wt%-NaCl was sprayed on weathering steel plate (150 x 70 x 6 mm) for about 10 months to generate the lamellar rust. Here, components of weathering steel are defined by Japanese Industrial Standards. Various surface preparation and repair painting are applied to corroded weathering steel plates, and these specimens were exposed. The exposure test started in September 2015 at Okinawa and Yamaguchi. Test in Okinawa is placed with a ceiling board to avoid rinsing by rain, but airborne salt will be able to come to the specimen, as shown in Figure 1. Test in Yamaguchi is placed in sealed boxes, which are not supplied airborne salt, as shown in Figure 2. Table 1 shows the exposure environment at each place. In order to observe the re-corrosion of specimens, rust/coating film thickness, ion transfer resistance, and appearance evaluation were measured once every 3 months. Here, ion transfer resistance is the resistance to the movement of ions in material, which is covered steel surface.

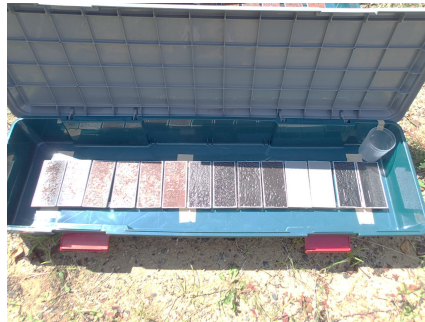
Figure 2. Exposure test at Yamaguchi.
