# RENOVATION OF CORRODED GIRDER END IN PLATE GIRDER BRIDGE WITH RESIN AND REBARS

There have been found a lot of corrosion damages recently in steel bridges aged for fifty or more years, especially in plate girder bridge, we can notice serious damages at girder ends involving supports. Then, the girder-end should be repaired adequately against the thickness loss caused by corrosion. This paper presents a repair method for corrosion damage at girder-end, in which rebars and shear connectors are fixed to the corroded member using with resin. In order to investigate the effect of recovered strength, we conducted axial compressive tests for six cruciform columns. One of the six specimens has no corrosion damage. The other five have the same unevenness imitated a corroded surface which is made artificially by drilling, for the purpose of grasping the quantitative effect by the repair method. During the test, ultimate strength and post buckling behavior of the cruciform columns are also investigated as well as recover effects. It is concluded from test results that this repair method can enhance the axial remaining strength sufficiently, beyond the ultimate strength of the non-corroded s

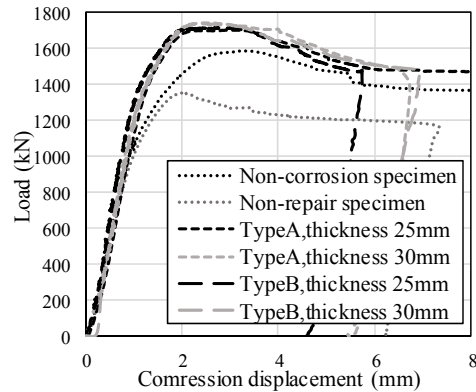
Figure 5. Load-Displacement.

Then, Load-Displacement curve is shown in Figure 5. The strength has dropped to 85% of the non-corroded specimen due to corrosion. And, by applying this repair method, it was recovered more than 100% strength of non-corroded specimen. In addition, throughout the all repaired specimens, the difference in the resin thickness and the location of studs do not affect the performance of recovery is confirmed, because very little difference to the failure mode and the strength appeared. Strength recovery effect of all specimens affected by the failure mode.

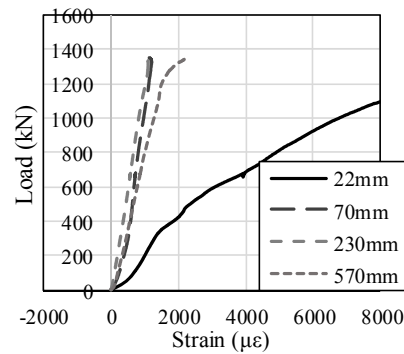
Figure 6. Compressive strain of Non-repaired specimen. (left)

The compressive strain in the height direction of the stiffener in the non-repaired specimen is shown in Figure 6. The compressive strain at 22mm height that is minimum cross-sectional area has increased remarkably from initial loading in the non-repaired specimen. It can be seen that the lower part that has terrible corrosion become fragile part, since it is also about  $1000 \sim 2000 \mu\epsilon$  even at the maximum loading in other parts. But, as shown in Figure 7 the compressive strain in minimum cross-sectional area was able to greatly reduce by applying this repair method. And it is understood that there is no much change in the bending strain of the rebar and the resin in comparing initial loading and after yield of the base metal, from bending strain of the rebar, resin and web that is shown in Figure 8. Furthermore, since the bending strain of the repair part is smaller than it of upper part at the maximum loading, it was confirmed that no buckling occurs in the repair part. In other words, it is able to eliminate the fragile part by repair.

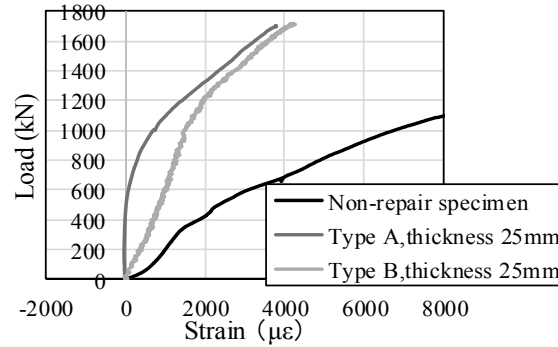
Figure 7. Compressive strain in minimum cross-sectional area. (right)
