# SEISMIC BEHAVIOR OF FRAMES WITH UNEVEN LARGE SECTION BEAMS OF TRADITIONAL WOODEN STRUCTURE

NORIKO TAKIYAMA and NAOTO IDATE

We report the progress of our research on understanding the seismic performance of frames with uneven large section beams and clarify the influence of the height of beams and the shape of fitting type joints on the behavior of the frame. In this study, we conducted a cyclic loading test for four test frames with spans of one or two and investigated the seismic performance and failure behavior. The major findings for the two-span frames are summarized as follows. (a) They caused fatal damage more readily than the one-span frames. The column that was caught in the even beams broke before other damage occurred. (b) Because of the asymmetry of the frame or the shape of the column-beam joints, the shear forces had directional dependence.

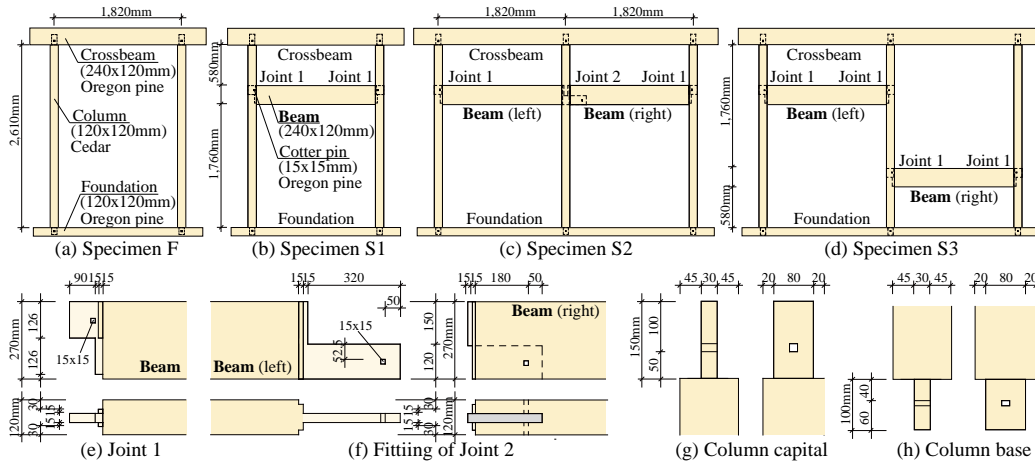
Figure 1. Details of specimens.

We designed three specimens based on a typical traditional wooden frame (see Figure 1). Specimen F is the standard frame. Specimen S1 is a frame with a large section

beam. Specimens S2 and S3 are two-span frames with beams. The uneven beams of Specimen 4 are exaggerated to verify whether they influence the seismic properties.
