EFFECT OF SEISMIC STRENGTHENING OF WOODEN BUILDING AS DETERMINED WITH MICRO-TREMOR MEASUREMENTS

MITSUHIRO MIYAMOTO¹ and YOSHIKI TOMINAGA²

¹*Dept of Safety Systems Construction Engineering, Kagawa University, Takamatsu, Japan*

²*Heritage Structure Engineering Design Inc., Osaka, Japan*

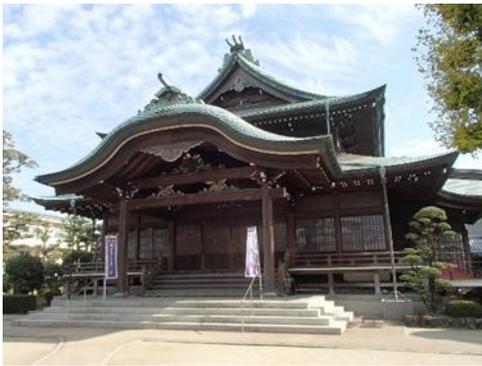
Figure 1. Exterior of temple.

The subject of this study was a single-story wooden temple in Asakura City, Fukuoka Prefecture. It is shown in Figures 1 and 2. The length and width of the structure were approximately 27.4 m and 21.6 m, respectively. The height was approximately 9.0 m, given the large size of the prayer space. The temple was constructed using a wooden frame with columns and beams, infilled with mud walls. The exterior and interior finishes were plaster. The roof was covered with copper sheathing.

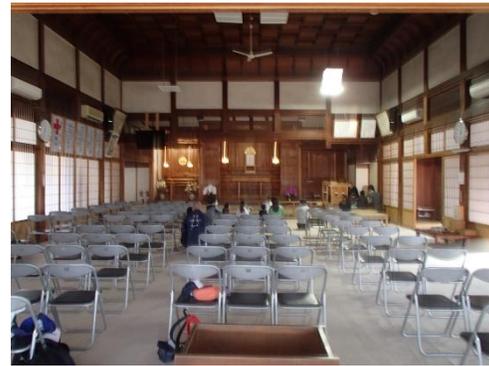
Figure 2. Interior of temple.

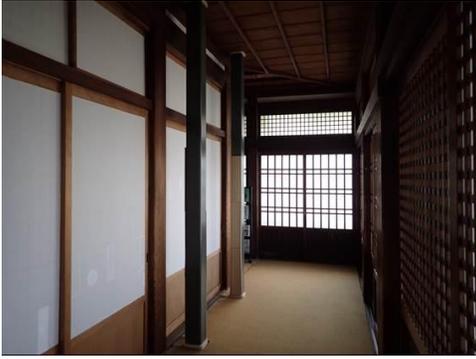
Figure 4. Steel column.

Figure 3 shows the arrangement of the seismic strengthening for the temple. Steel columns were installed at the entrance and in the middle of the prayer space, as shown in Figure 4. Steel braces were installed in the attic space to prevent the deformation of entrance wall due to the eccentricity of the seismic walls, as shown in Figure 5. The hanging walls of the corridors were strengthened using structural plywood to transfer any seismic forces to the steel columns. The connections between the wooden braces were strengthened with metal plates for the same reason.

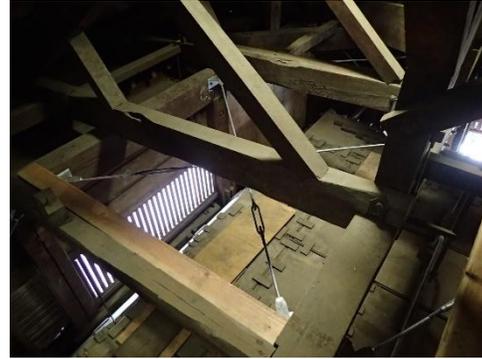
Figure 5. Steel braces in horizontal plane.
