DEVELOPMENT OF A SYSTEM TO VALIDATE AND CERTIFY EQUIPMENT AND TECHNICIANS FOR UNDERGROUND PIPE INSPECTION

Rinker School of Construction Management, University of Florida, Gainesville, USA

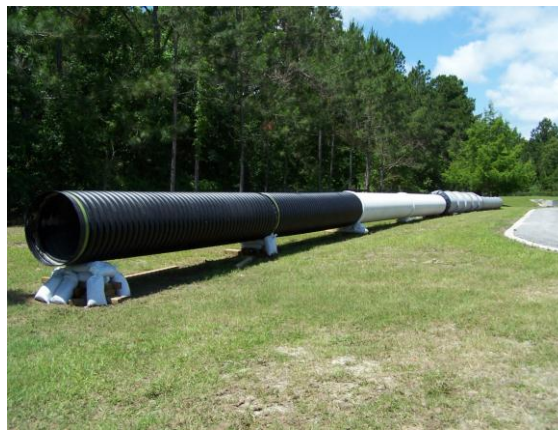
After the equipment and testing methods were approved, the research team produced two written examinations of 40 questions each to test the understanding of specifications, inspection procedures, and equipment criteria. The field test was designed and constructed to test proficiency in using approved methods of inspection. The course was comprised of one run each of varying pipe material: high-density polyethylene (HDPE), polyvinyl chloride (PVC), reinforced concrete pipe (RCP), and corrugated metal pipe (CMP) (Figure 1). The pipe run contained a variety of defect types, including cracks, deflections, excessive joint gaps, debris, and misalignments. Techniques for scoring the field test, grading the results, and recertifying the operators would be established.

Figure 1. Field Course Comprised of HDPE, PVC, RCP, and CMP.
