BASE ISOLATION IN SEISMIC RETROFITTING OF R/C BUILDINGS

ALBERTO DUSI¹, MARCO MEZZI² and TAN TENG OR³

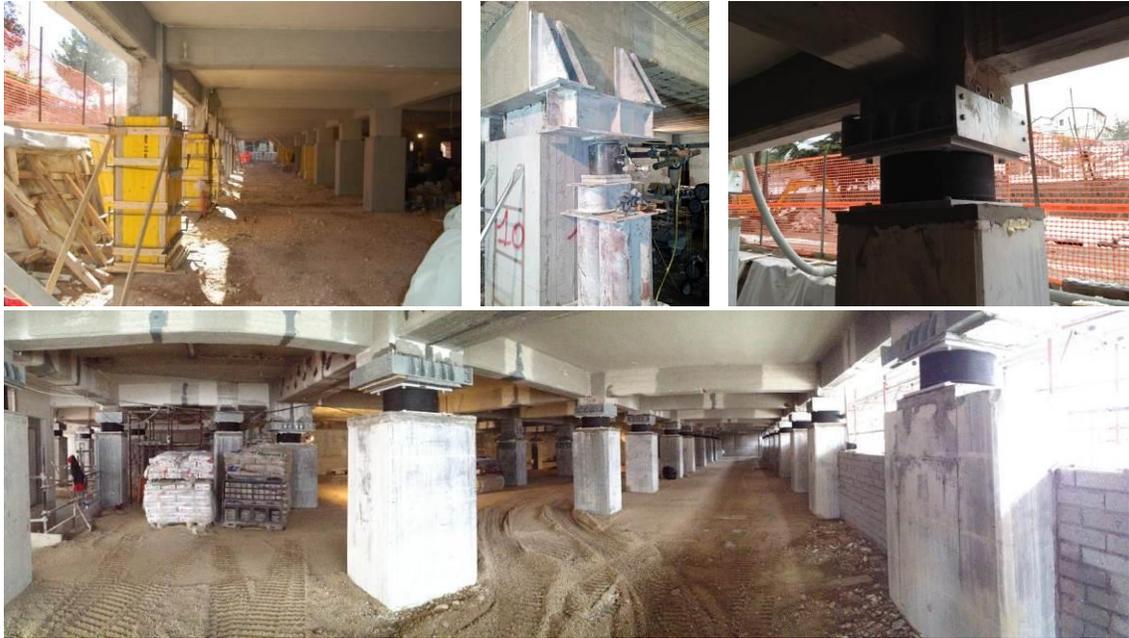
The base isolation option was considered as the preferred solution since the very beginning of the design for the seismic improvement of the building. This was mainly due to the possibility to do most of the works at the basement level only, almost completely avoiding strengthening works at the elevation in spite of the generalized low seismic-resistant capacity of the primary structural system. The following interventions have been conceived: cutting of the top portions of the columns at basement level, insertion of isolating devices, strengthening of the columns below the cut and of the joints above the cut, demolition and reconstruction of the first flight of the stairs. Figure 2 shows some details of the base isolation works. The isolating system, consisting of one

type of High Damping Rubber Bearings (HDRB) 650mm diameter and sliders, allowed to reach a base isolated period of 2.62 s and participating mass percentage almost equal to 99%.

Figure 2. Pictures of works for the base isolated retrofit.

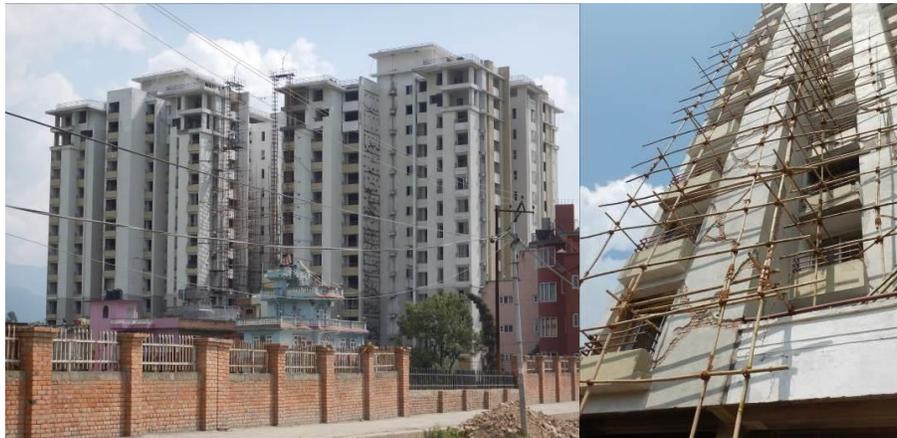
A damage survey has been carried out and a number of r/c buildings, representative of currently used Nepalese earthquake resistant structural schemes, have been selected by the authors for the vulnerability assessment and retrofit intervention designs. In the following the focus is on a building complex, hereinafter referred to as the “Downtown complex”, made of two towers of 15 floors each resting on a common underground basement (Figure 3). The “Downtown complex” was in an advanced construction stage at the time of the earthquake and suffered damage to both structural and nonstructural elements.

Figure 3. The “Downtown building complex”.
